INVESTIGATING LANDSLIDES IN VIRGINIA *IDENTIFICATION, MAPPING AND EMERGENCY RESPONSE*

ANNE CARTER WITT - GEOLOGY AND MINERAL RESOURCES PROGRAM
ANNE.WITT@ENERGY.VIRGINIA.GOV

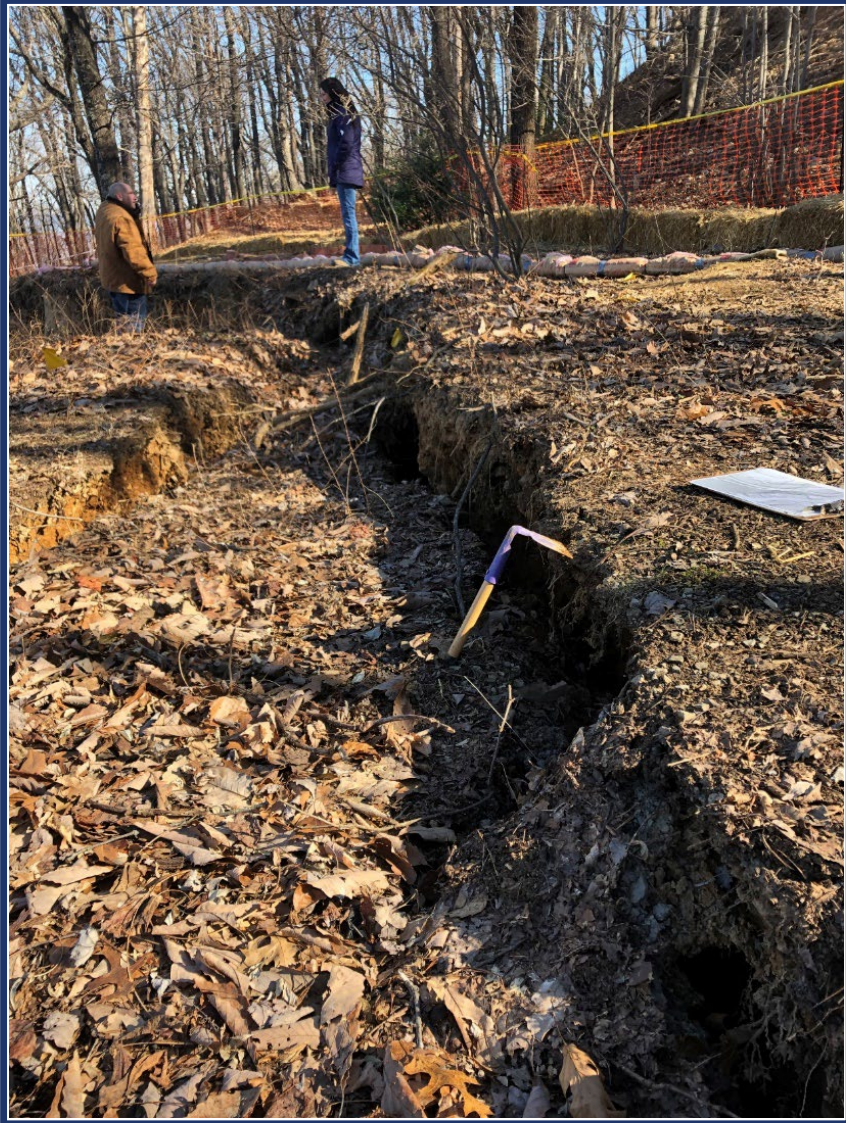
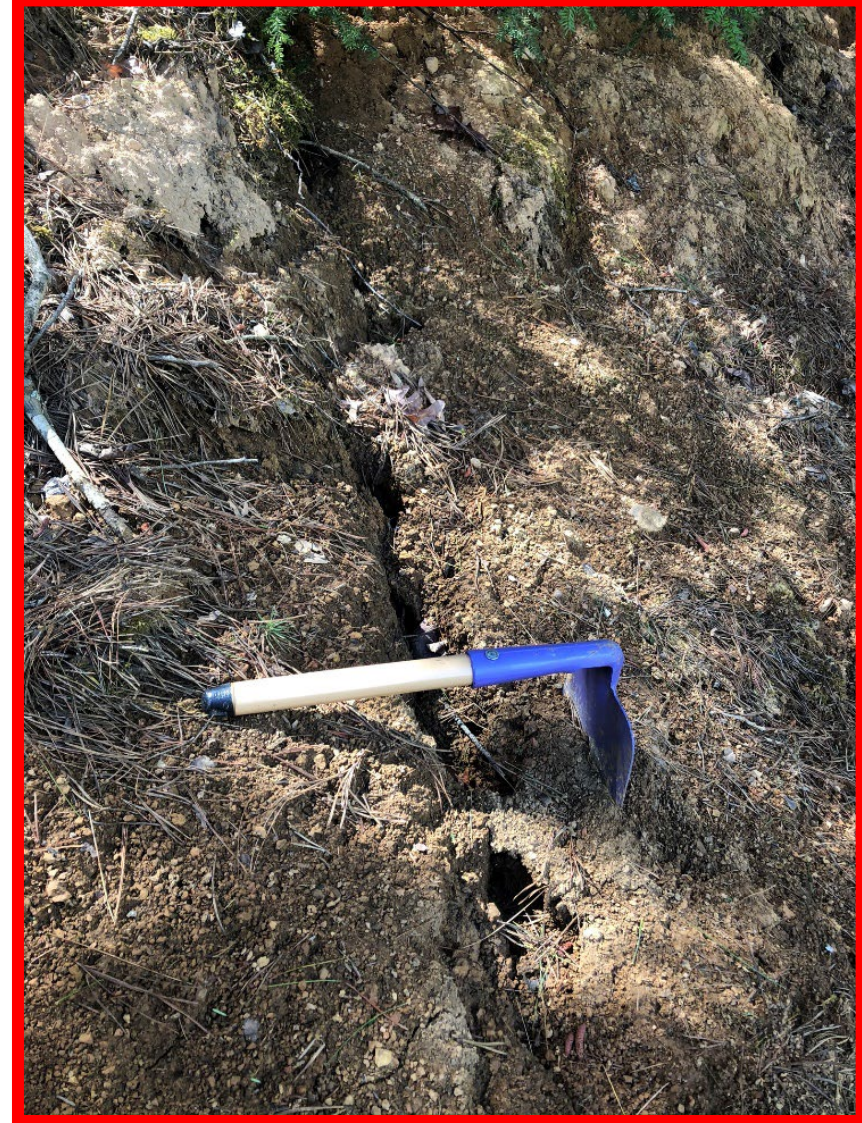
SOIL CRACKING – TENSION CRACKS

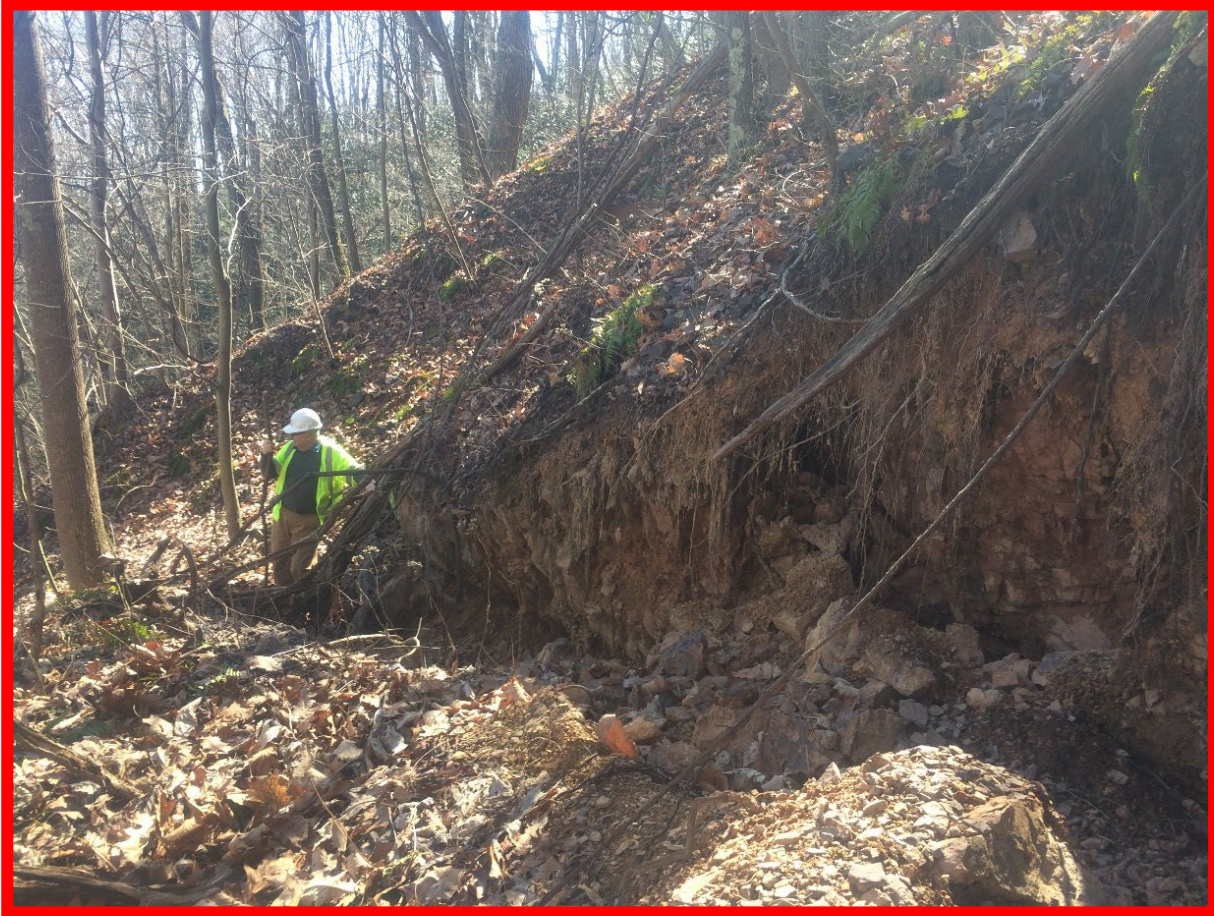
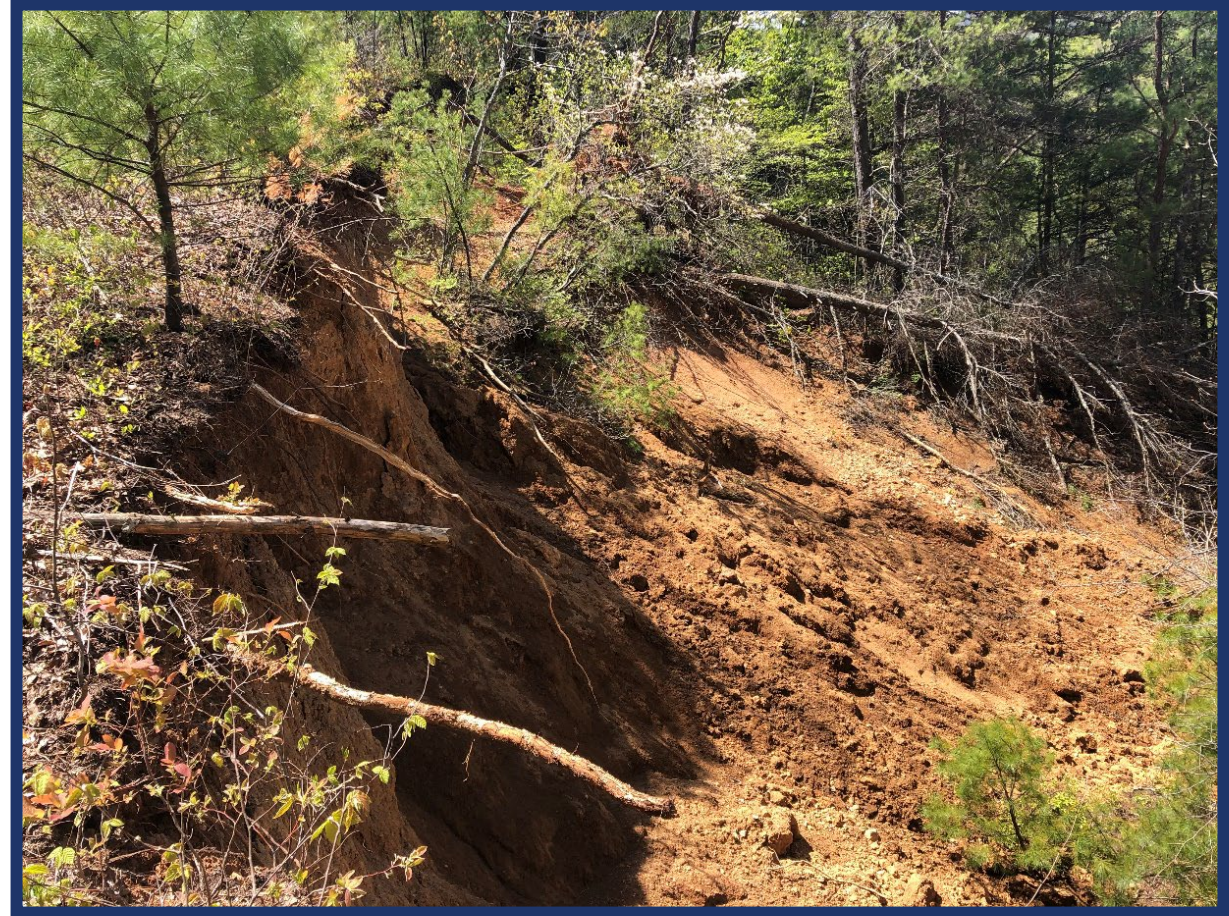
SOIL CRACKING – SCARPS

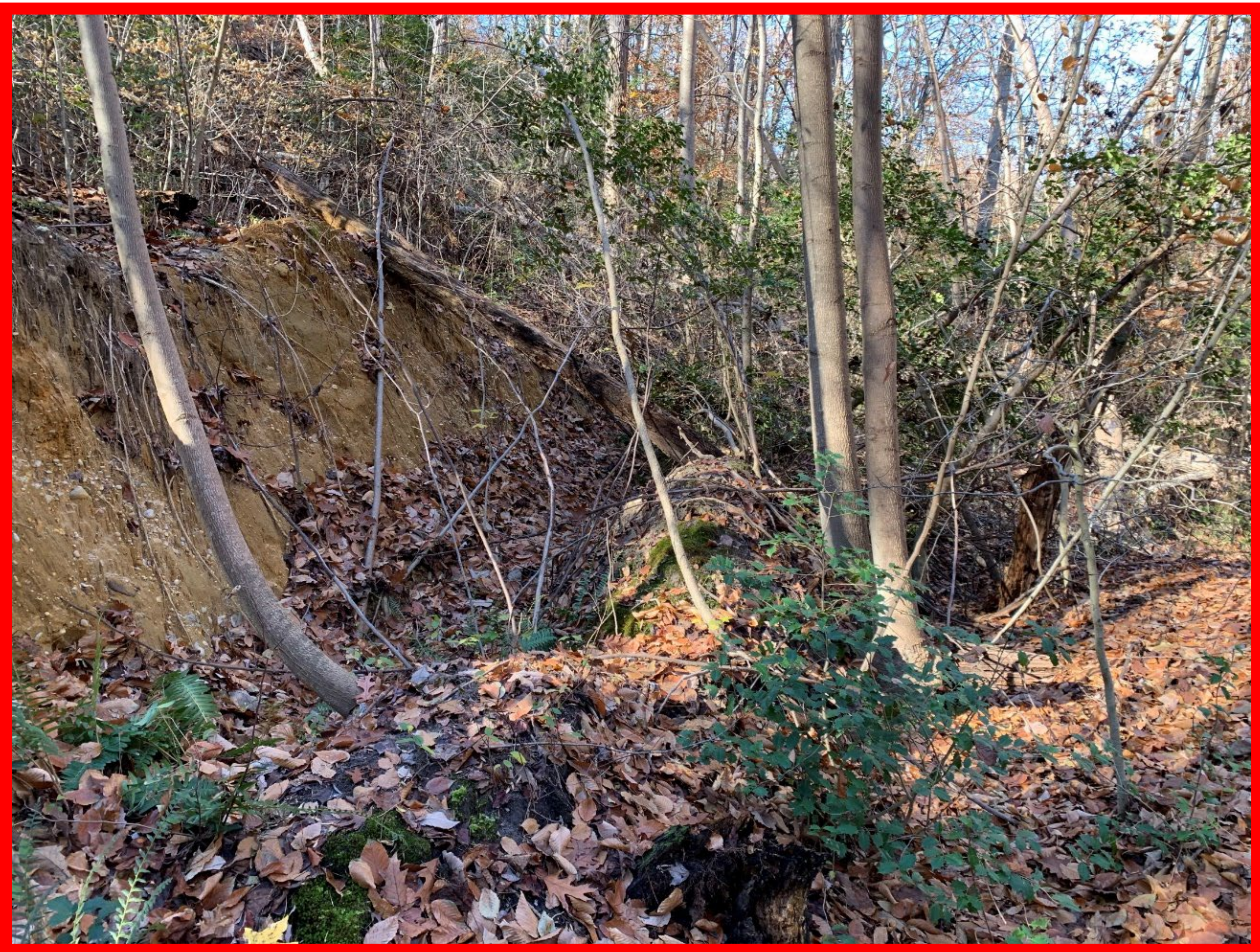
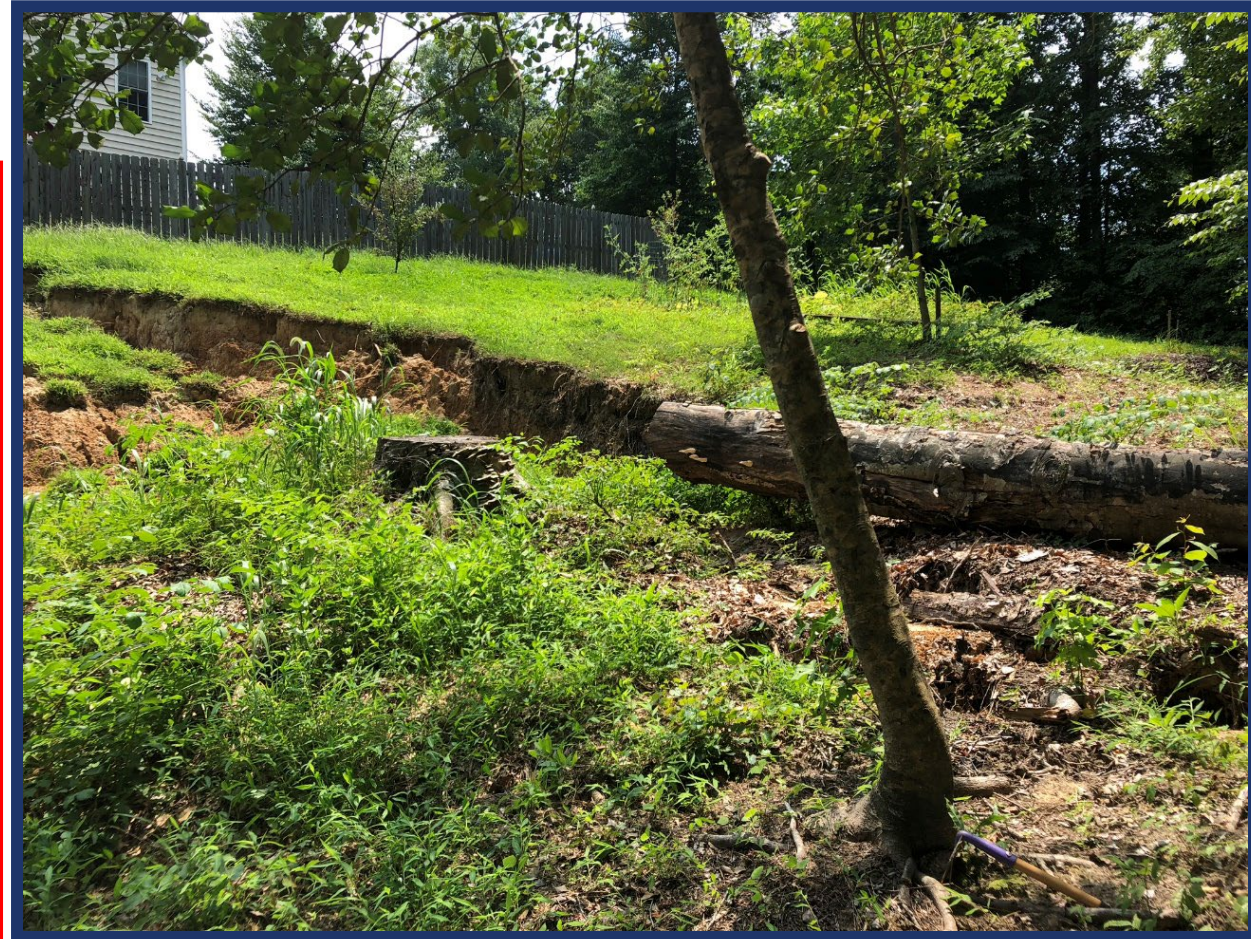
LEANING OR BACK ROTATED TREES

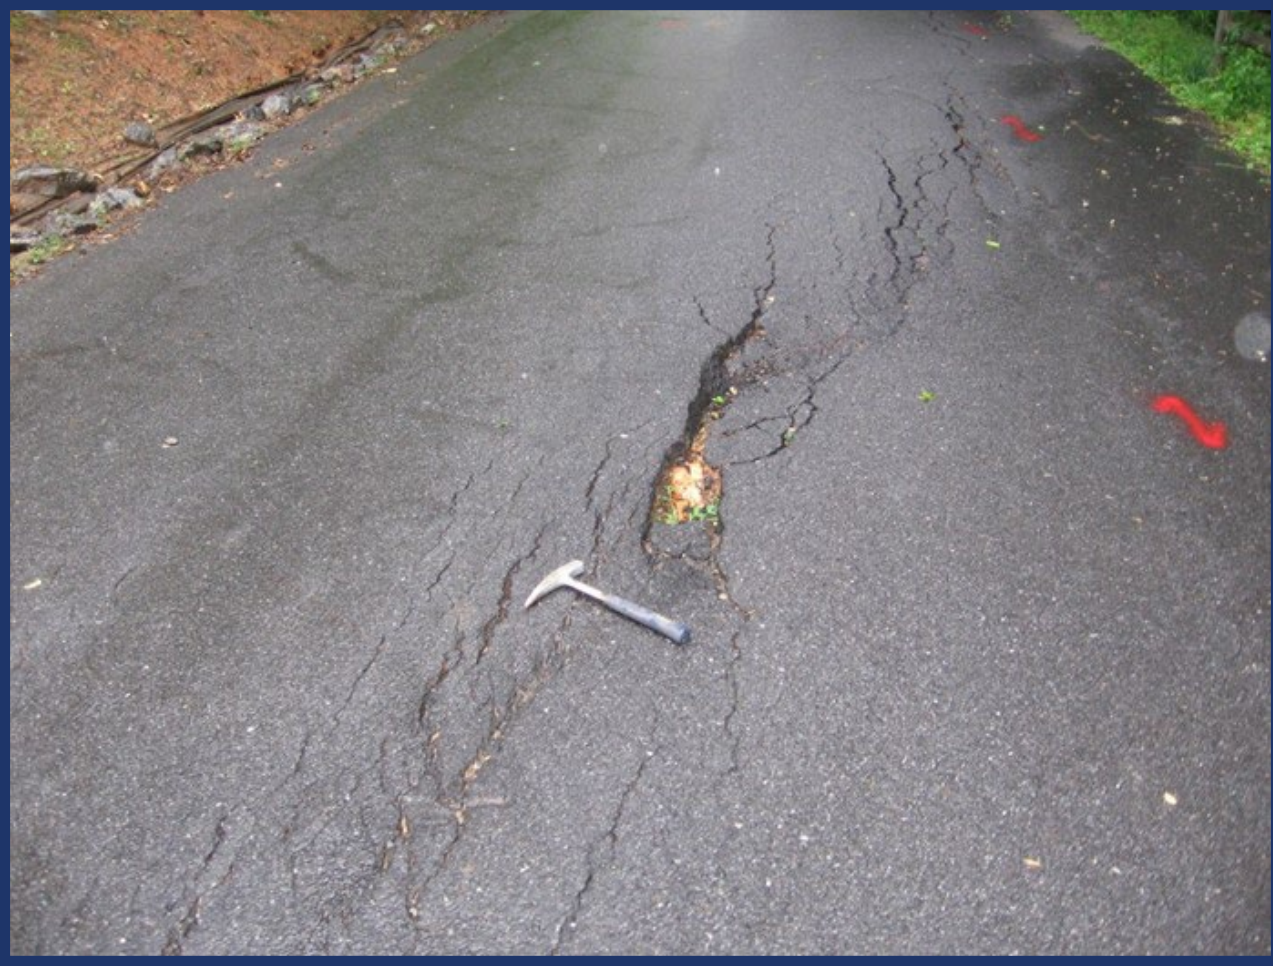
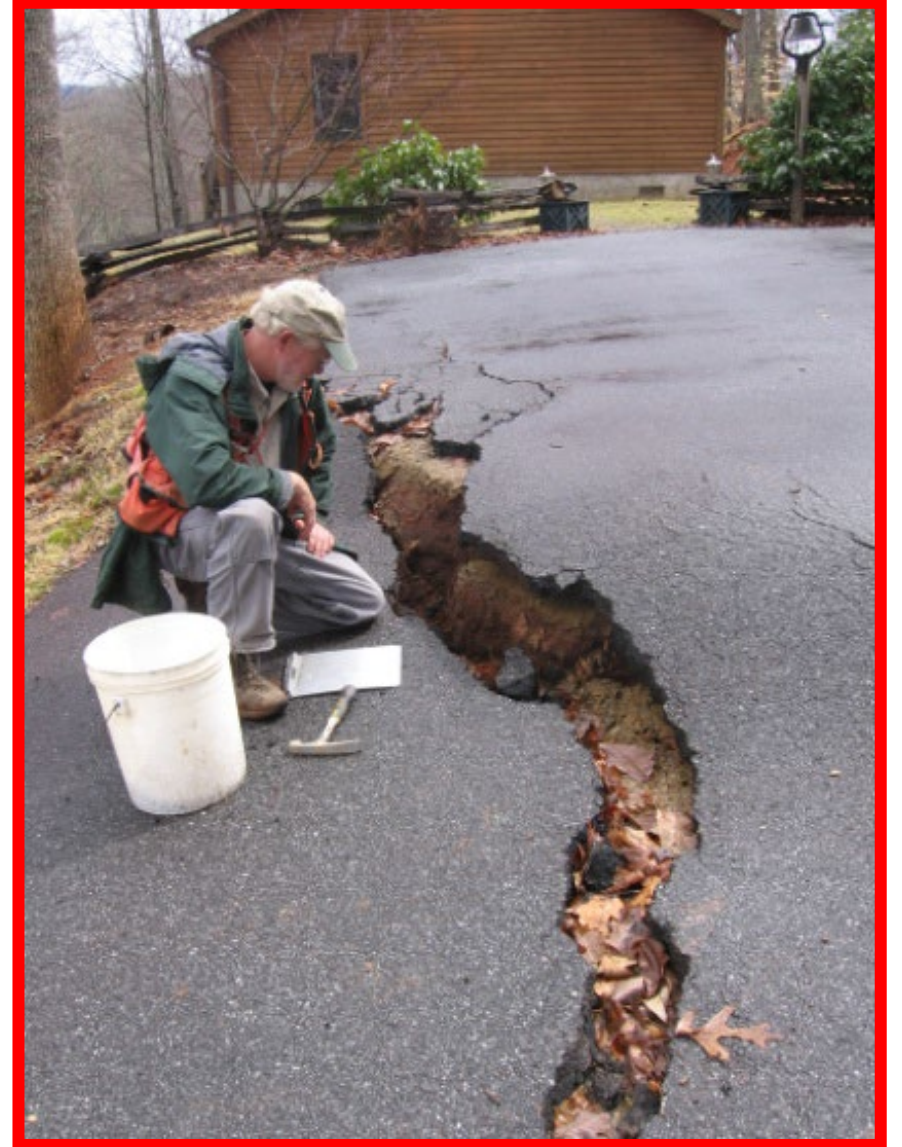
SUNKEN OR BROKEN ROADS, DRIVEWAYS

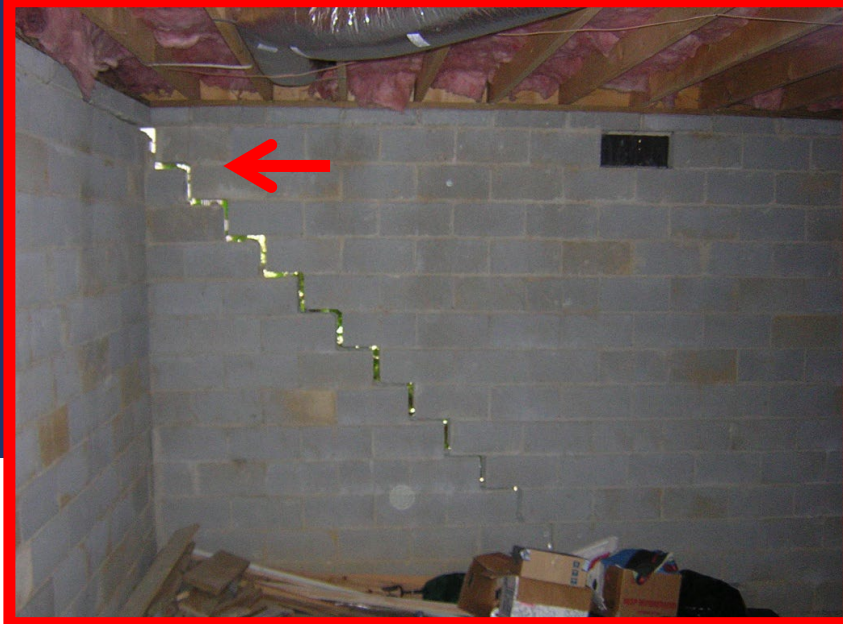
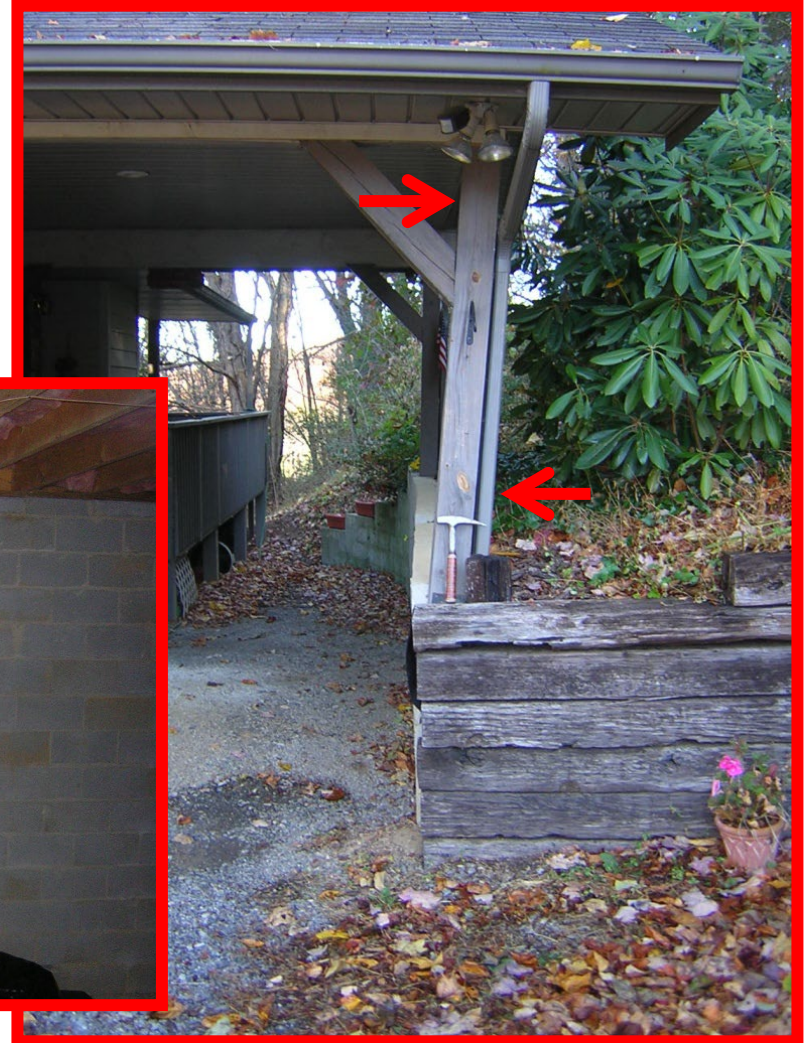
DAMAGE TO PROPERTY

- Sticking doors and windows
- Broken or leaking utilities (water, septic, sewer)
- Growing cracks in walls or ceilings
- Water wells that suddenly run dry

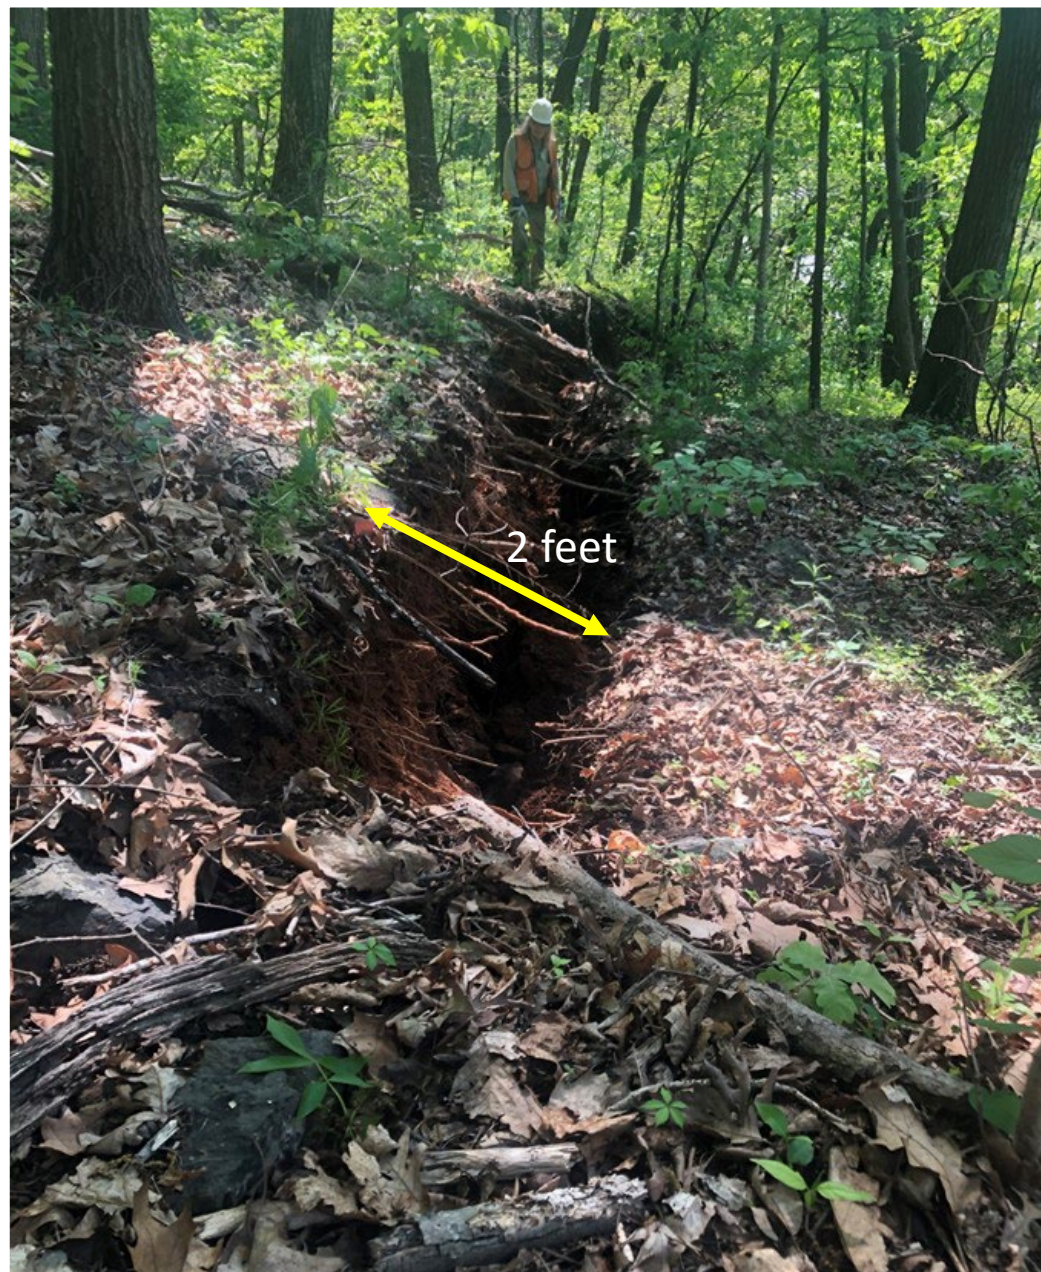
Large tension crack to east of main slide

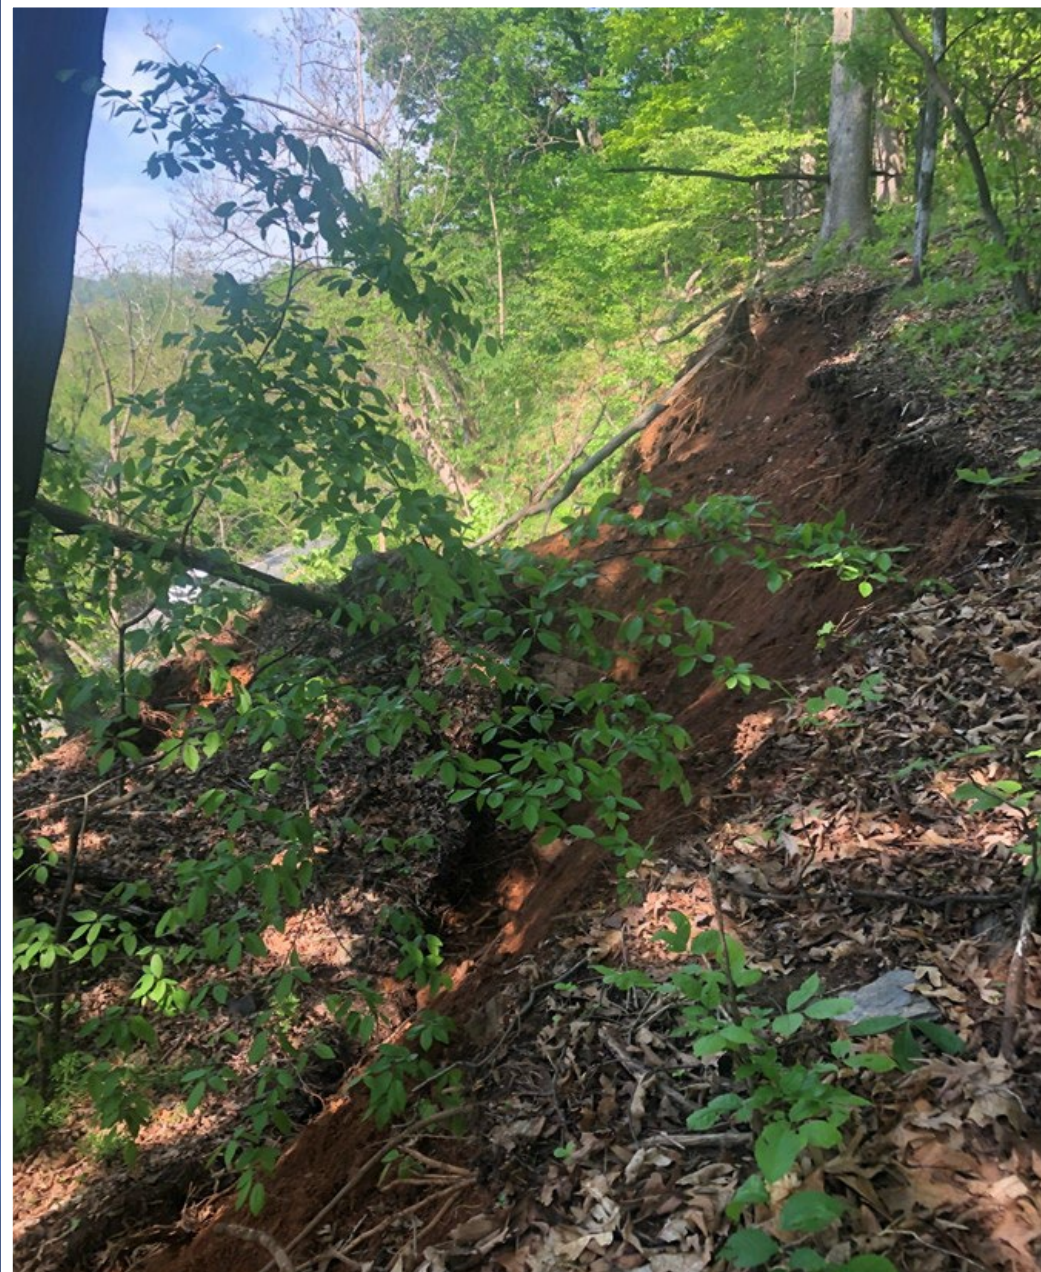
Headscarp

- This was classified as a rockslide on site, due the material and style of movement.
- A large tension crack to the east indicated that additional movement could occur.
- Also the site of other past rockslides which could be identified on aerial photography and LIDAR.

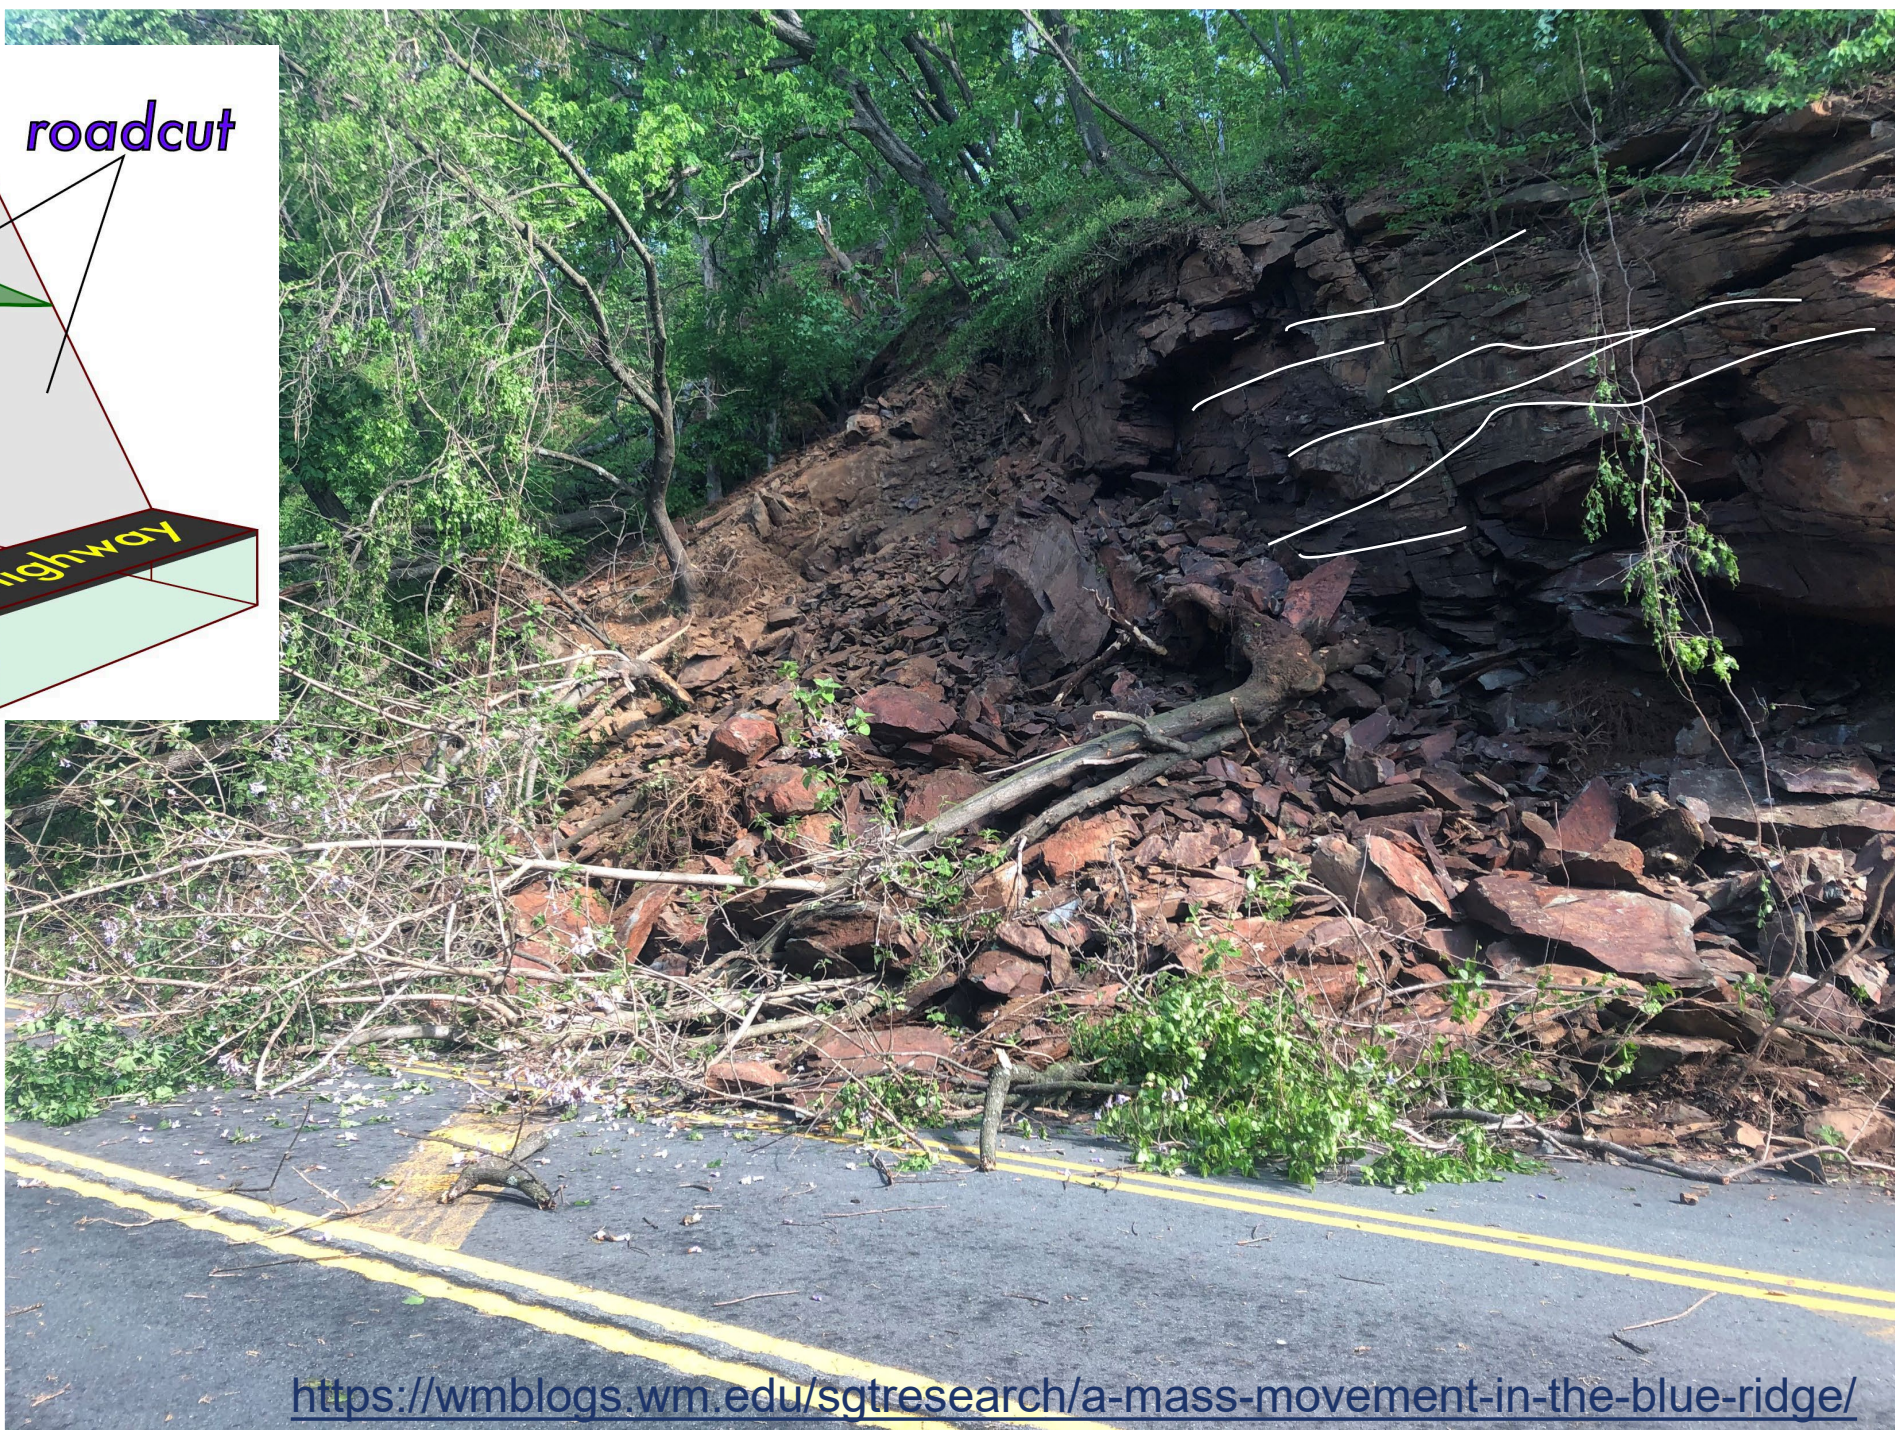
Road cut along
US 250 is steep
with daylighting
foliation
surfaces.

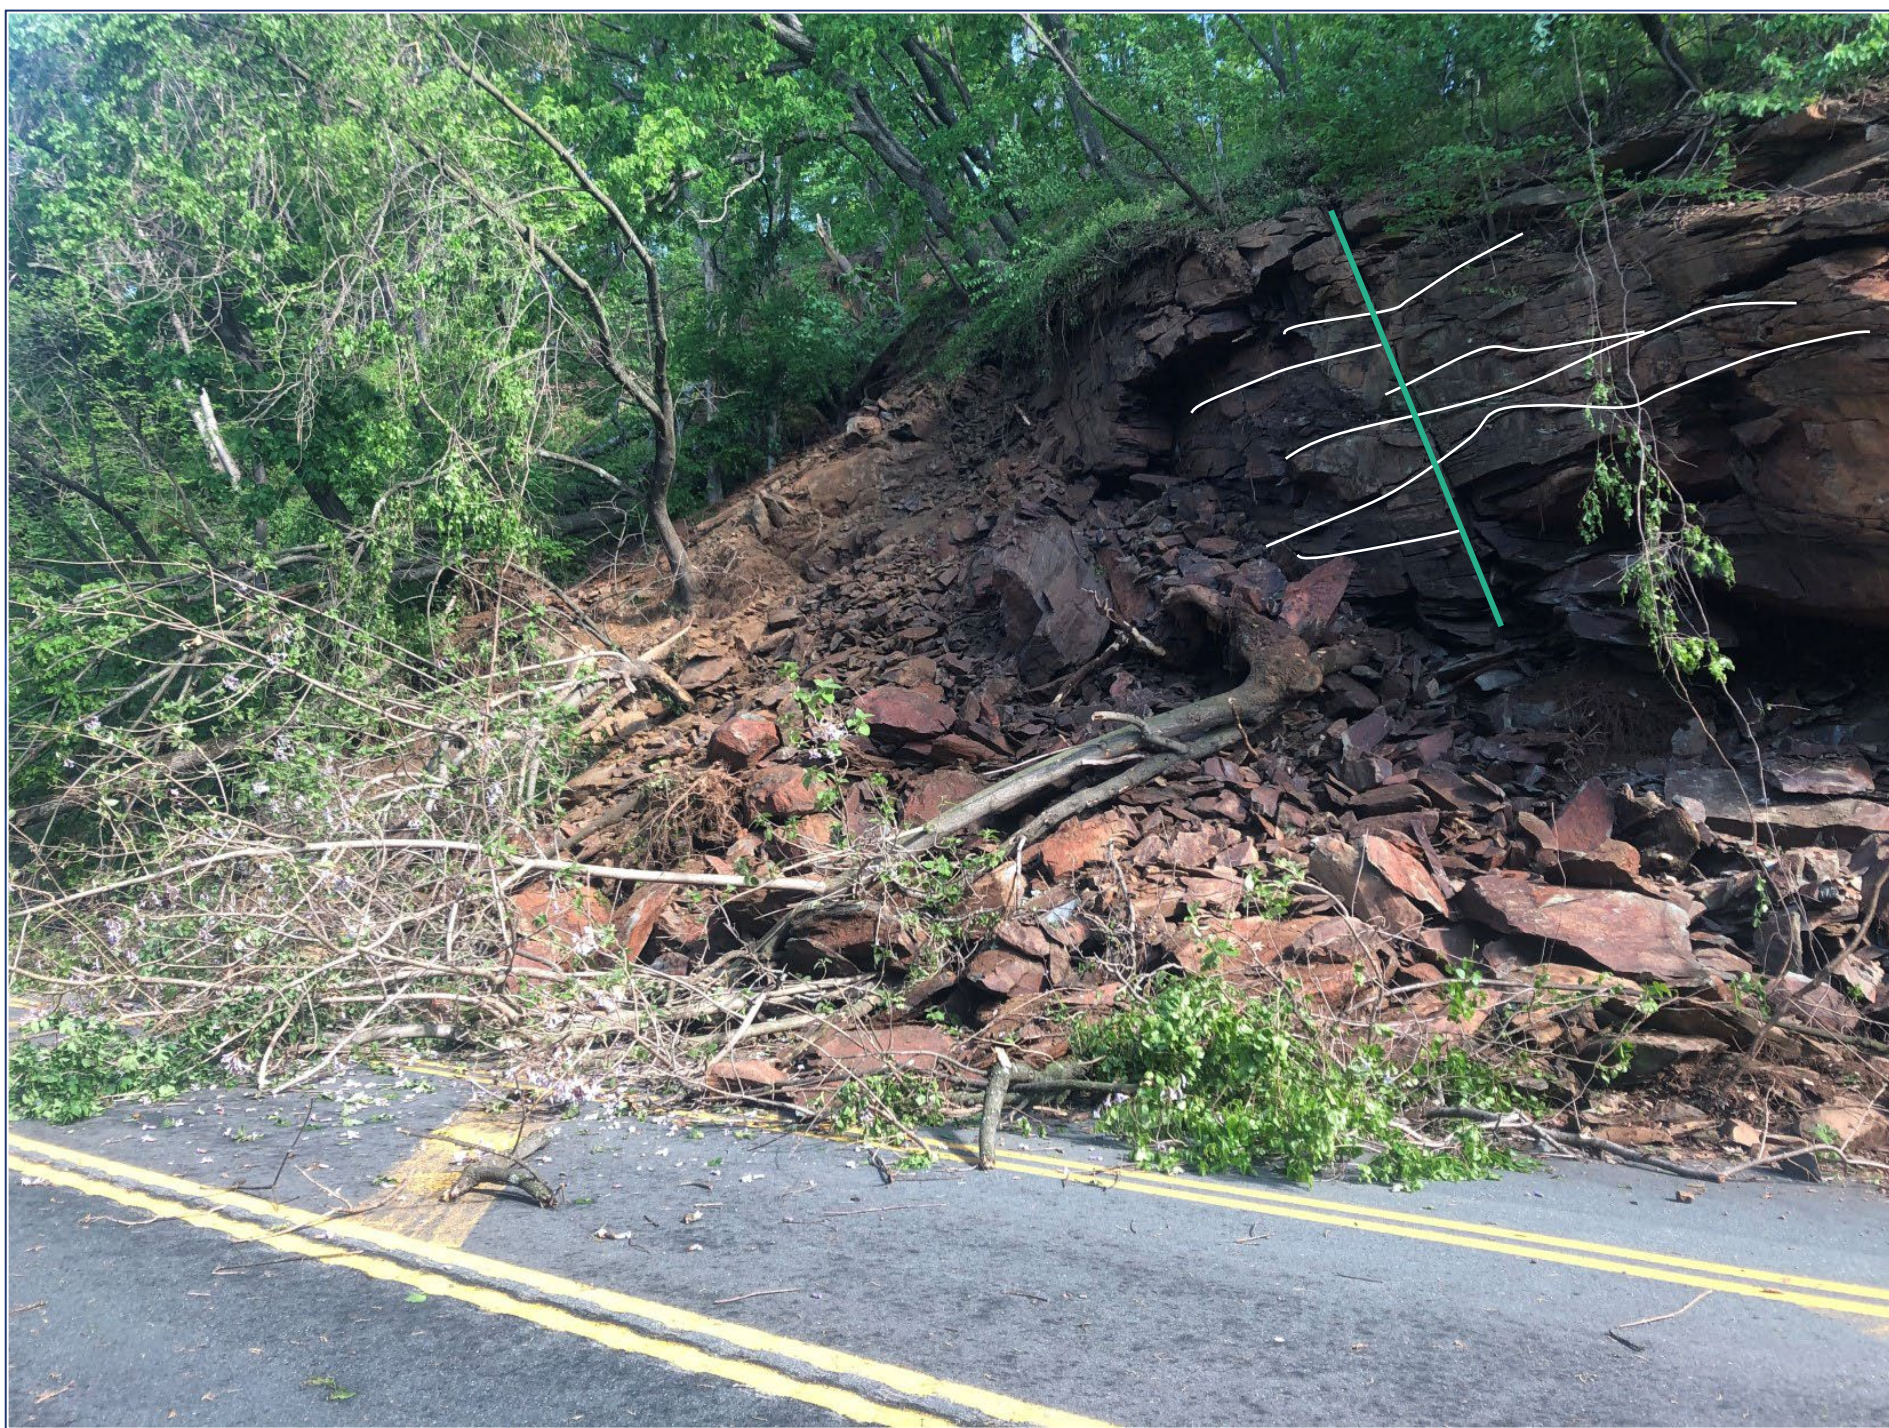
Joints (fractures) are also present in the Catoctin. They often form regular patterns and are also natural areas of weakness in the rock.

The green line is a joint that is perpendicular to foliation.

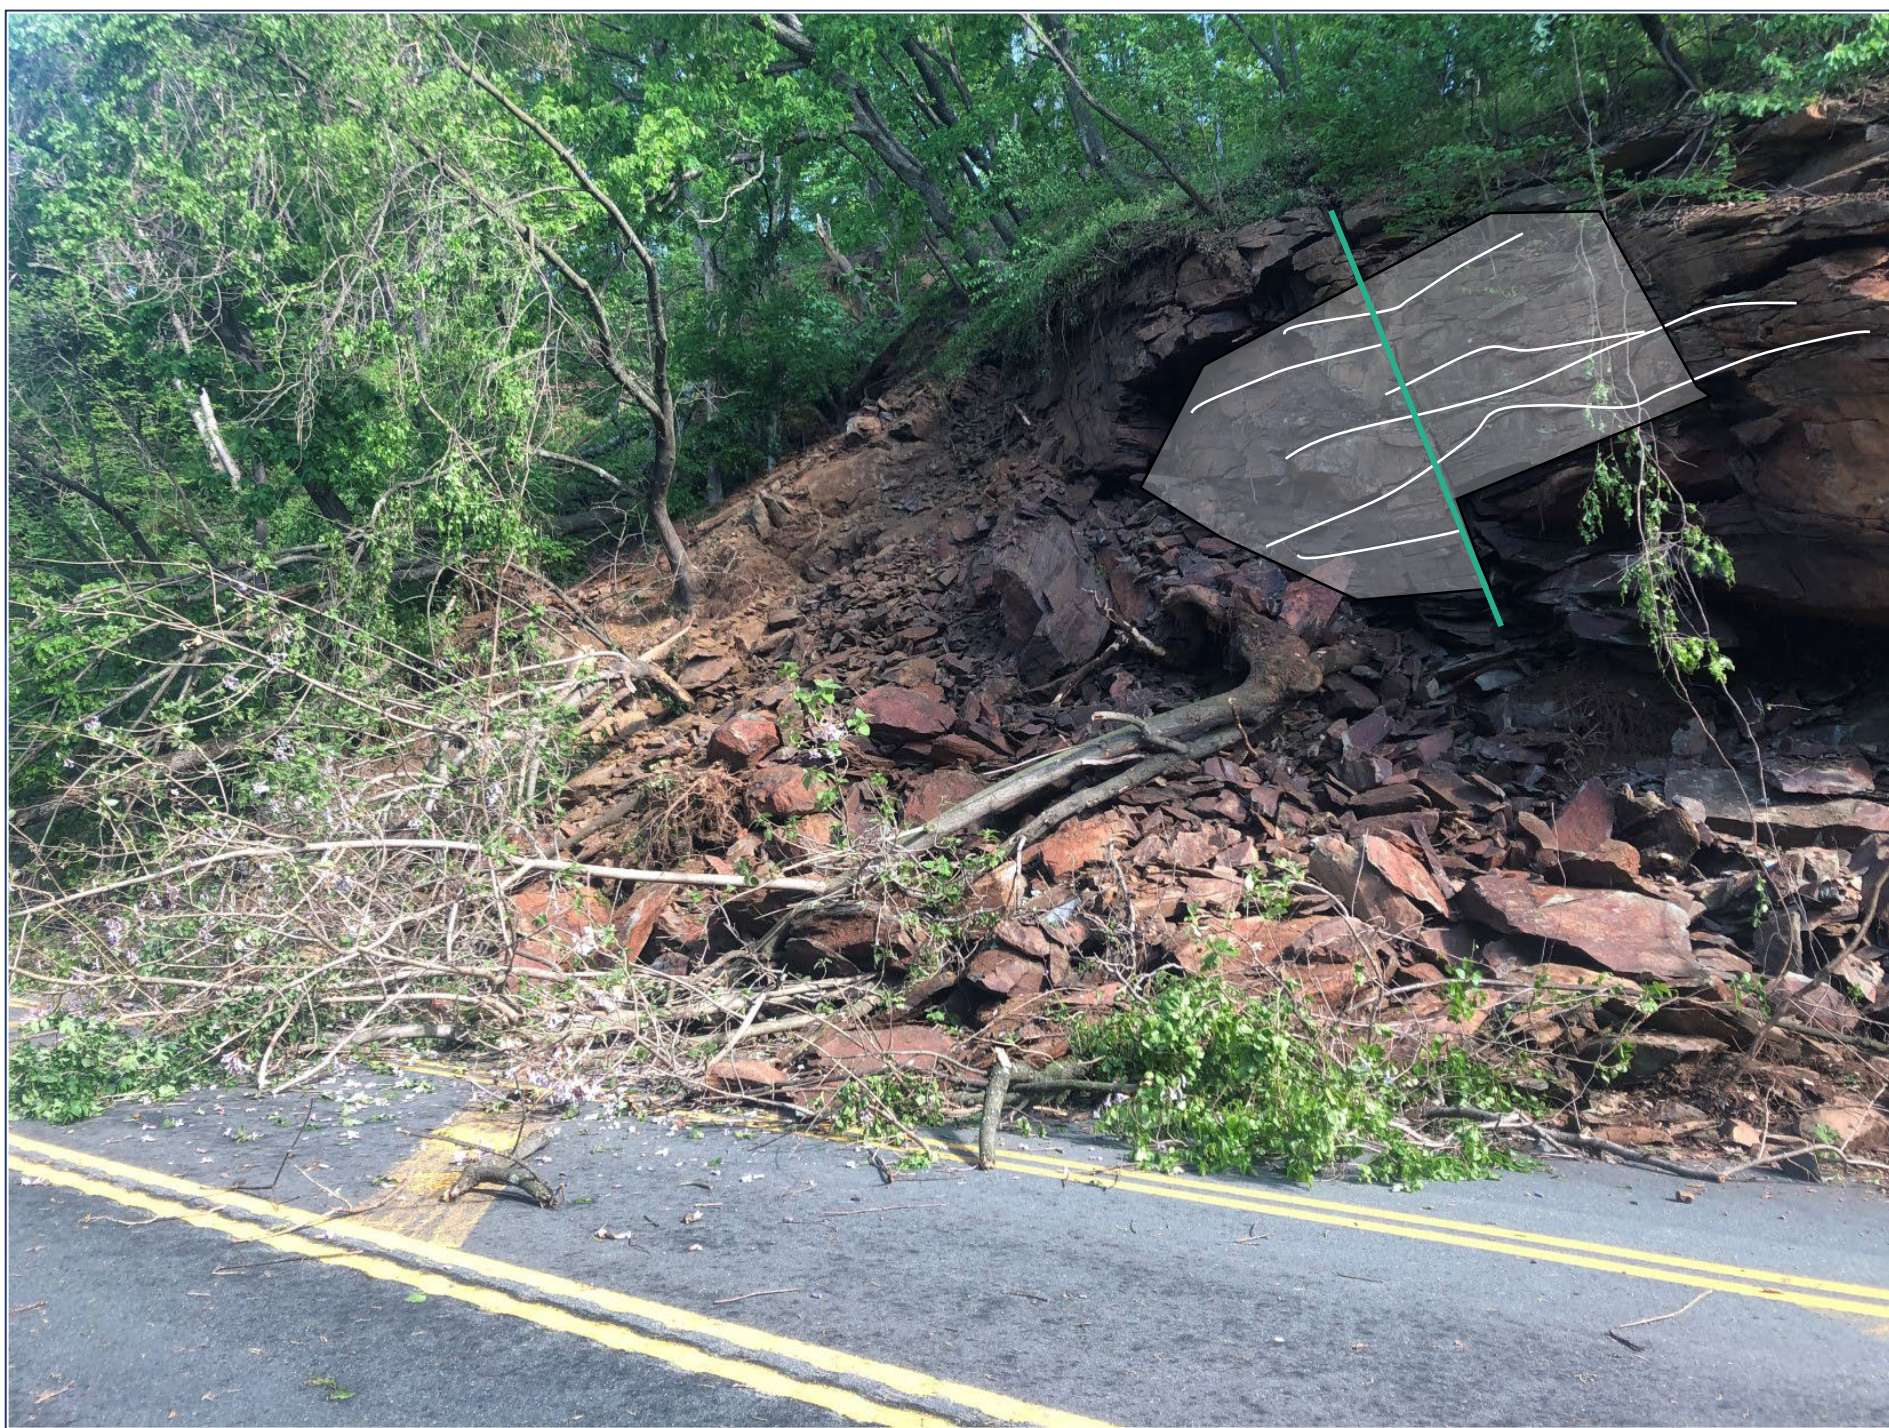
Joints (fractures) are also present in the Catoctin. They often form regular patterns and are also natural areas of weakness in the rock.

The green line is a joint that is perpendicular to foliation.

There is also a joint surface that is perpendicular to the road. This is the release surface of the rockslide and is parallel to the tension cracks and headscarp.

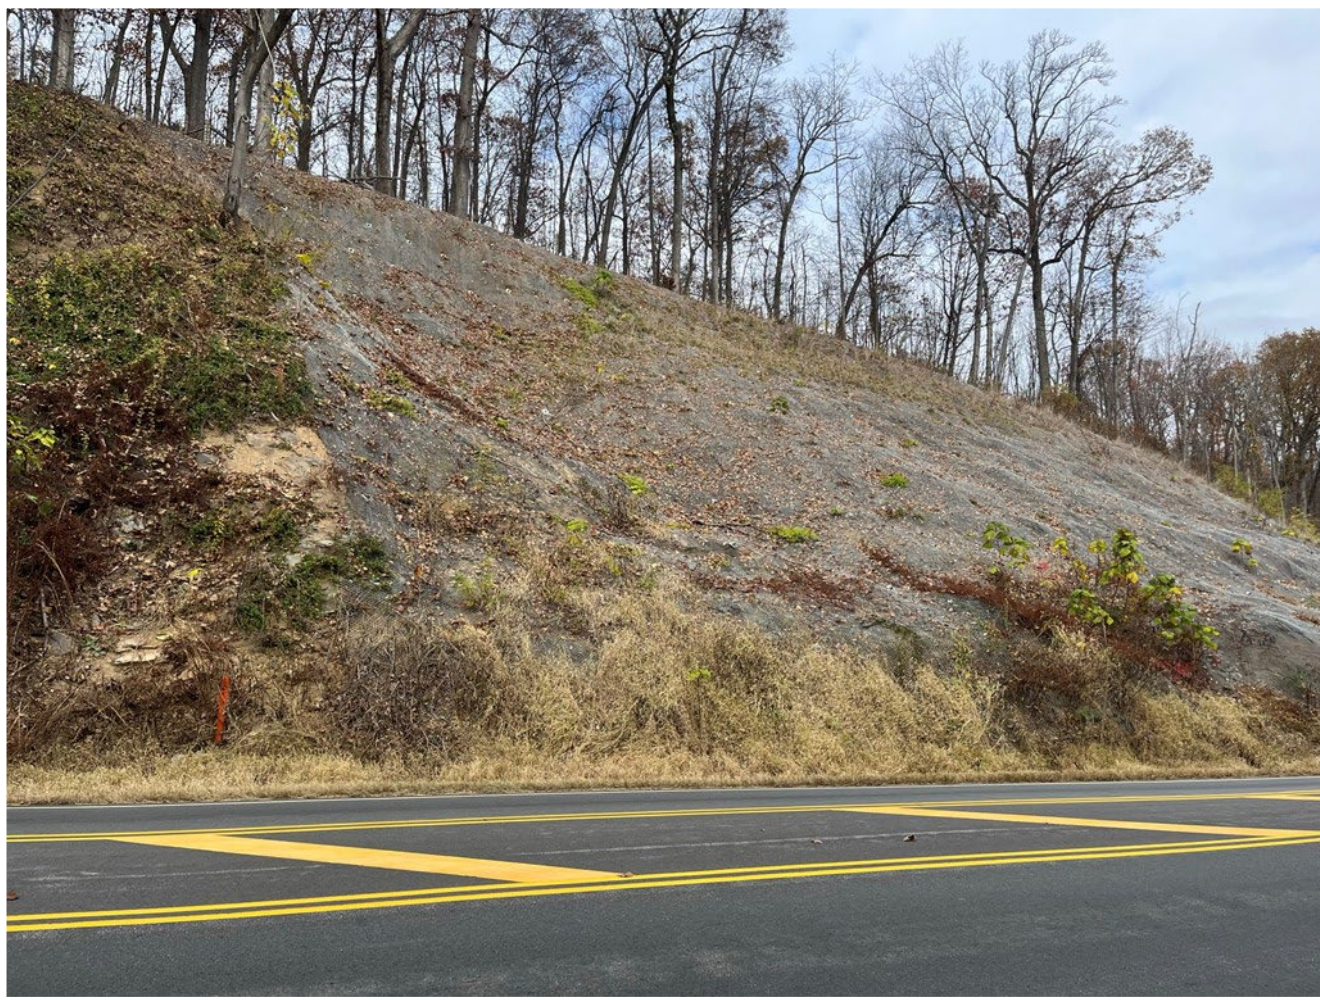
Tension cracks and scarping did not extend very far above the main headscarp, however the large tension crack to the east suggested that more of the area was unstable than previously thought.

- US 250 was closed for eight weeks and reopened June 30
- 700 dump trucks of unstable material were removed (about 10,000 tons) including the area below the large tension crack
- 350 soil nails were placed to stabilize the slope
- Area covered with anchored steel mesh to prevent soil and rock from falling into the roadway
