INVESTIGATING LANDSLIDES IN VIRGINIA *IDENTIFICATION, MAPPING AND EMERGENCY RESPONSE*

ANNE CARTER WITT - GEOLOGY AND MINERAL RESOURCES PROGRAM
ANNE.WITT@ENERGY.VIRGINIA.GOV

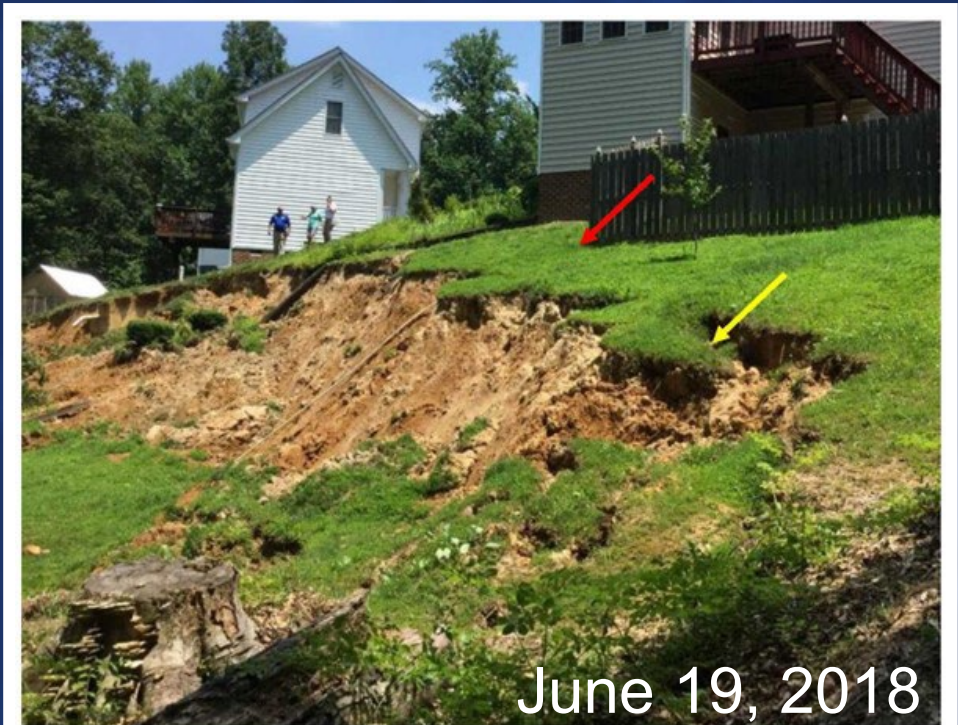
June 19, 2018

- GMR was first alerted to the landslide on June 19 as a request for assistance from VDEM and the King William Dept of Emergency Management
- First reported as a sinkhole behind two houses at 360 and 362 Nottoway Lanel
- Both homes were condemned on June 19

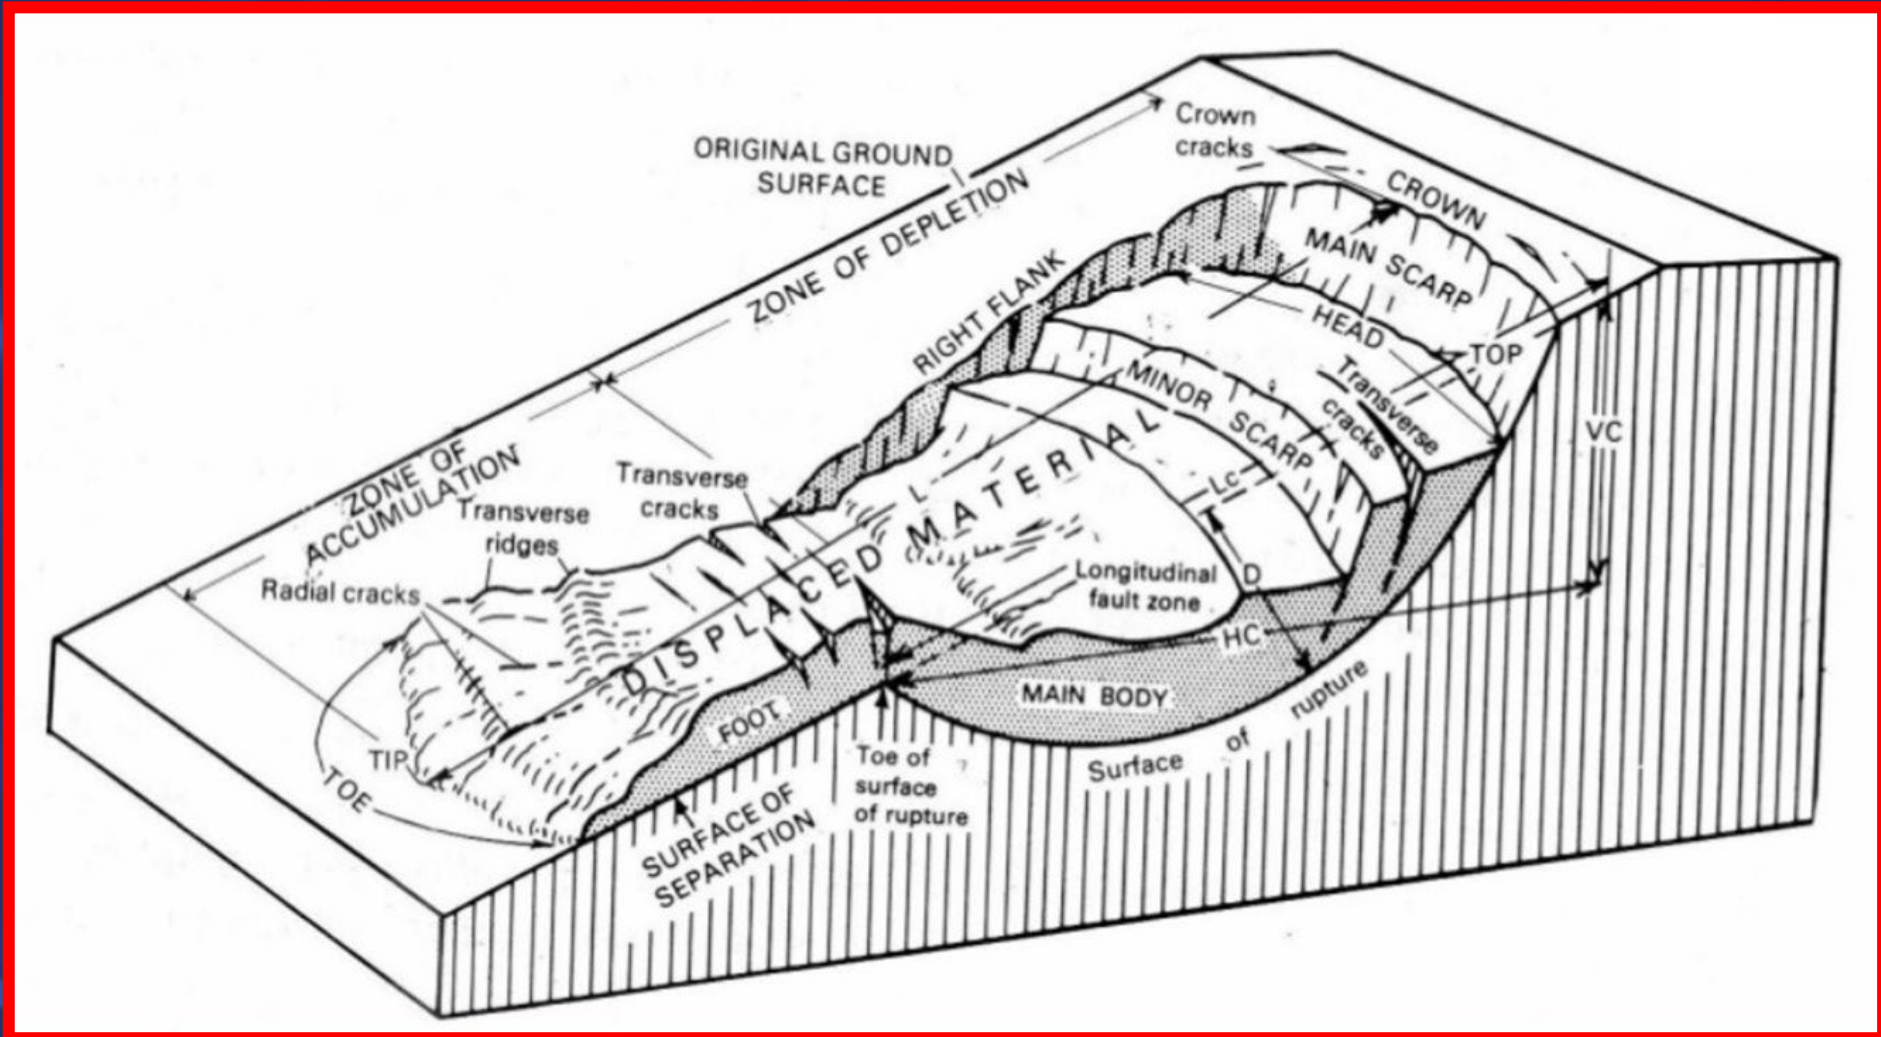
Based on this evidence, the feature was identified as a rotational debris slide-flow based on Cruden and Varnes (1996) classification.

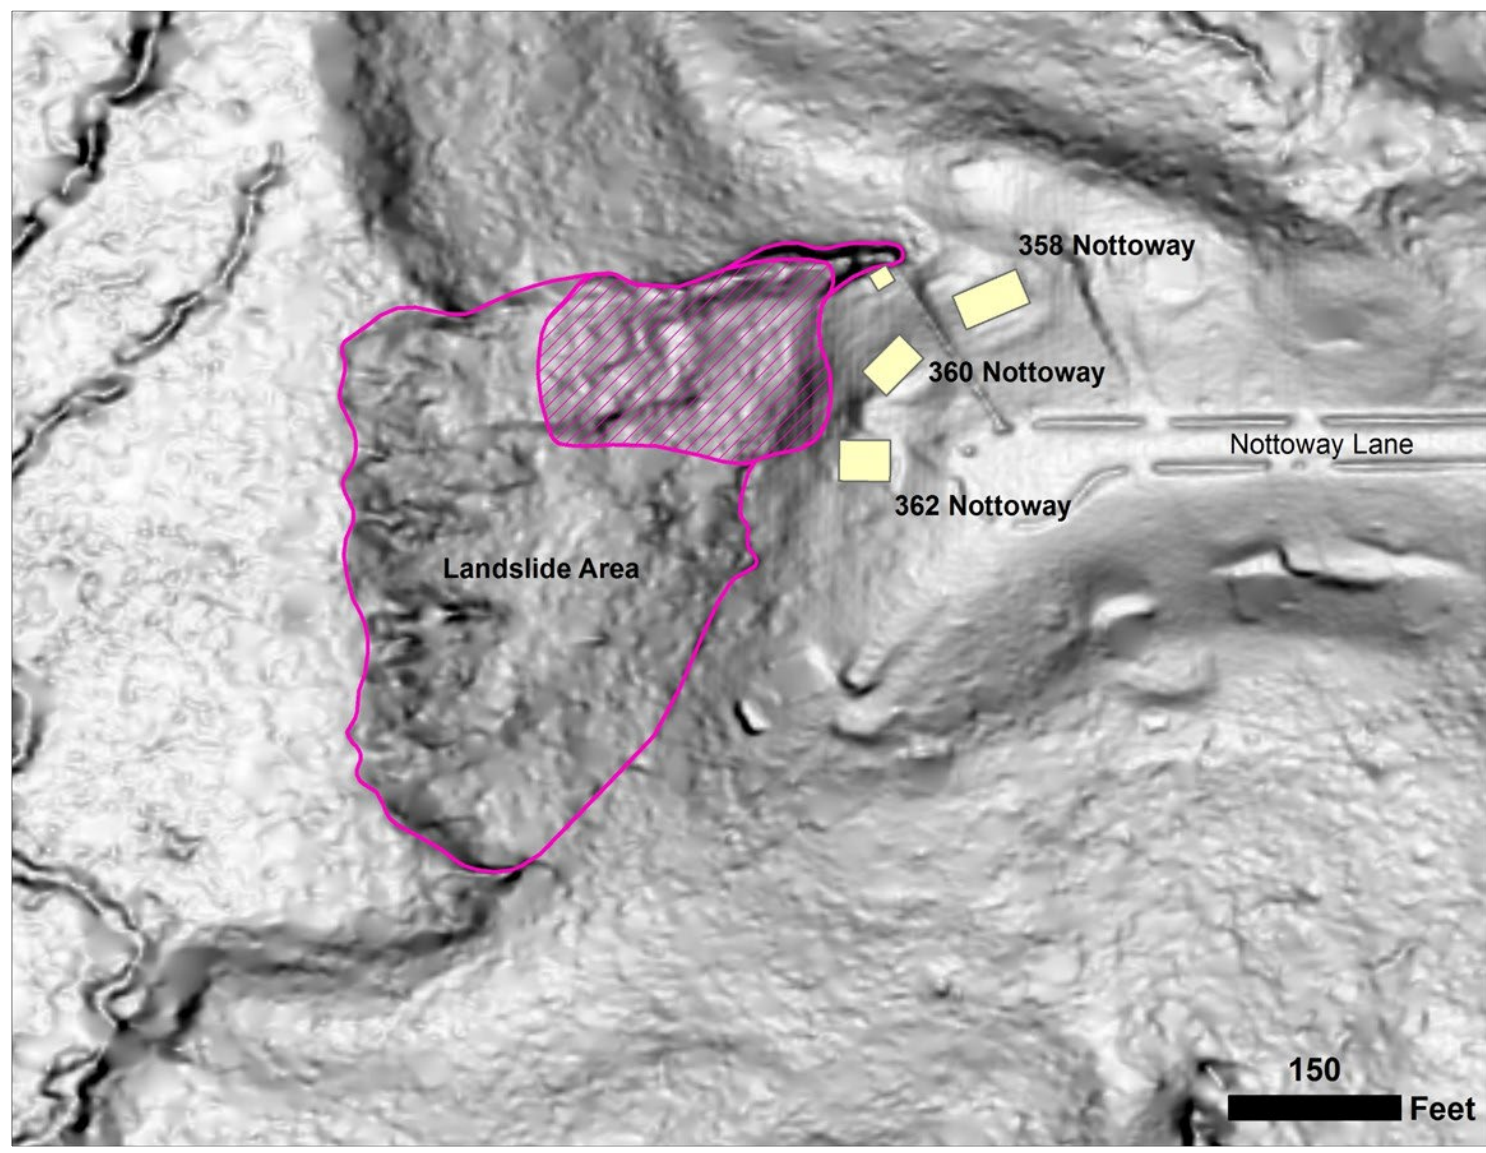
2011 LiDAR Slopeshade – 2.5 foot pixel resolution

Owner of 362 Nottoway confirmed that he had noticed cracking and slumping in his backyard for the past seven years.

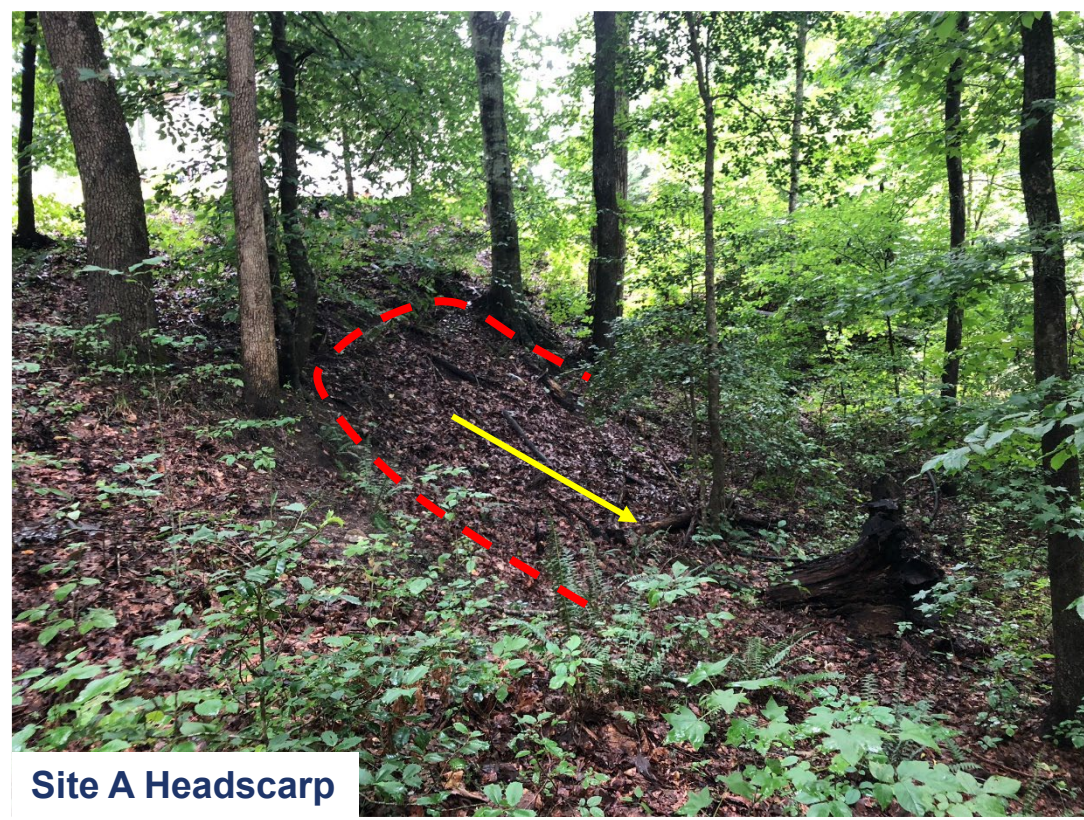
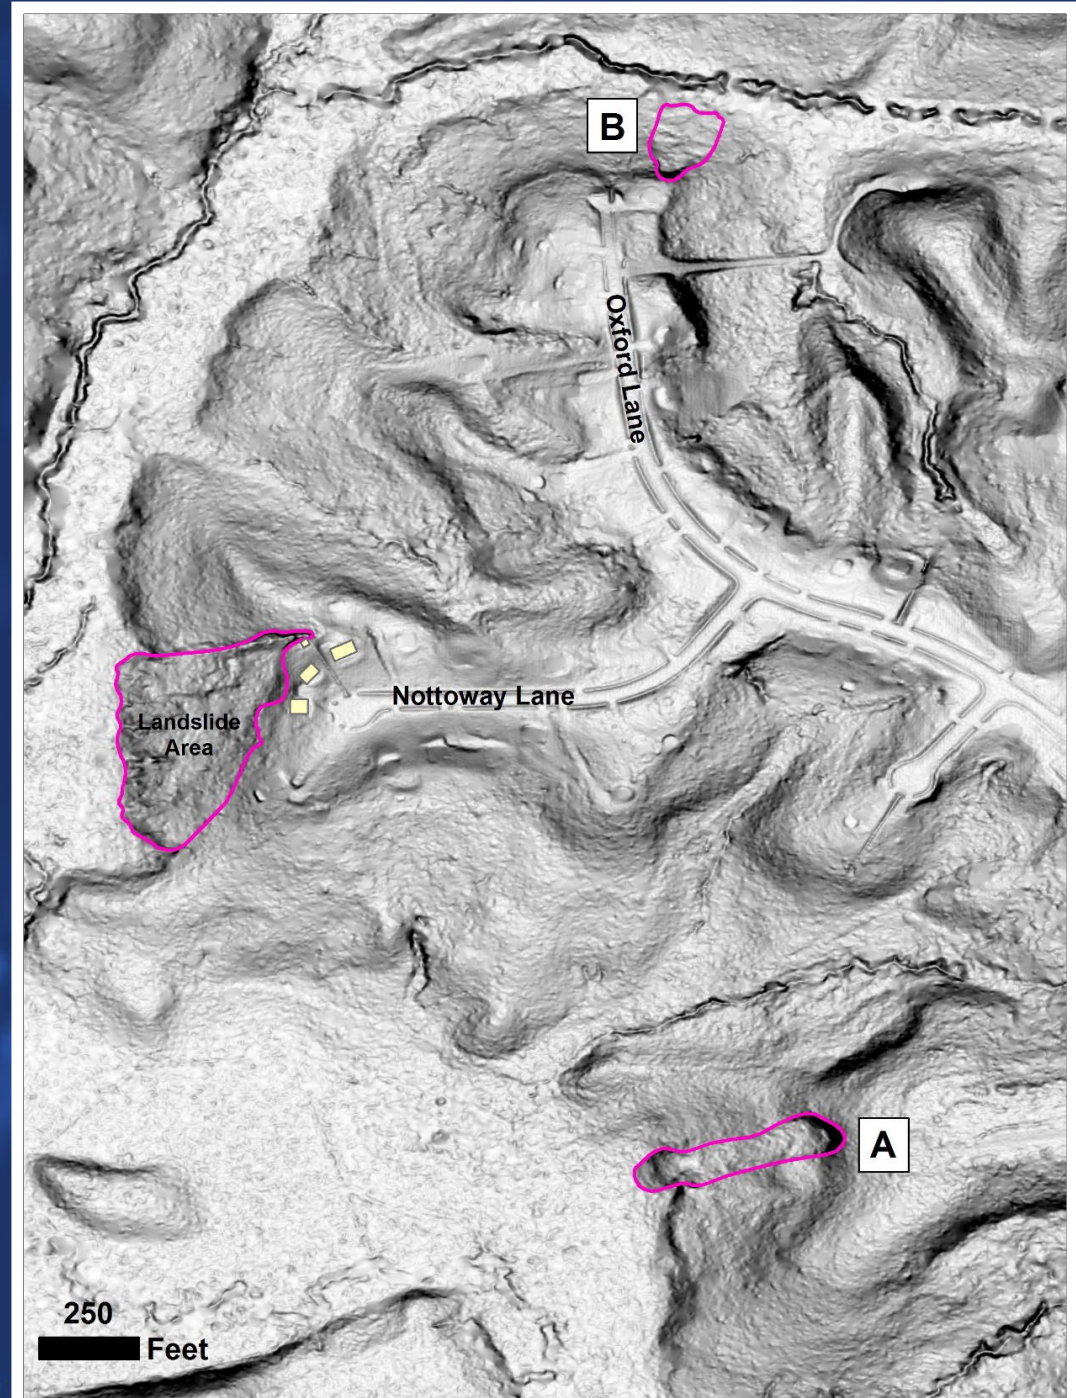
- Revisited neighborhood July 25:
 - Site A = Debris flow
 - Site B = Debris slide
- Both had significant regrowth in the head scarps → landslides were older than 10 years
- Neither posed a threat to life or property

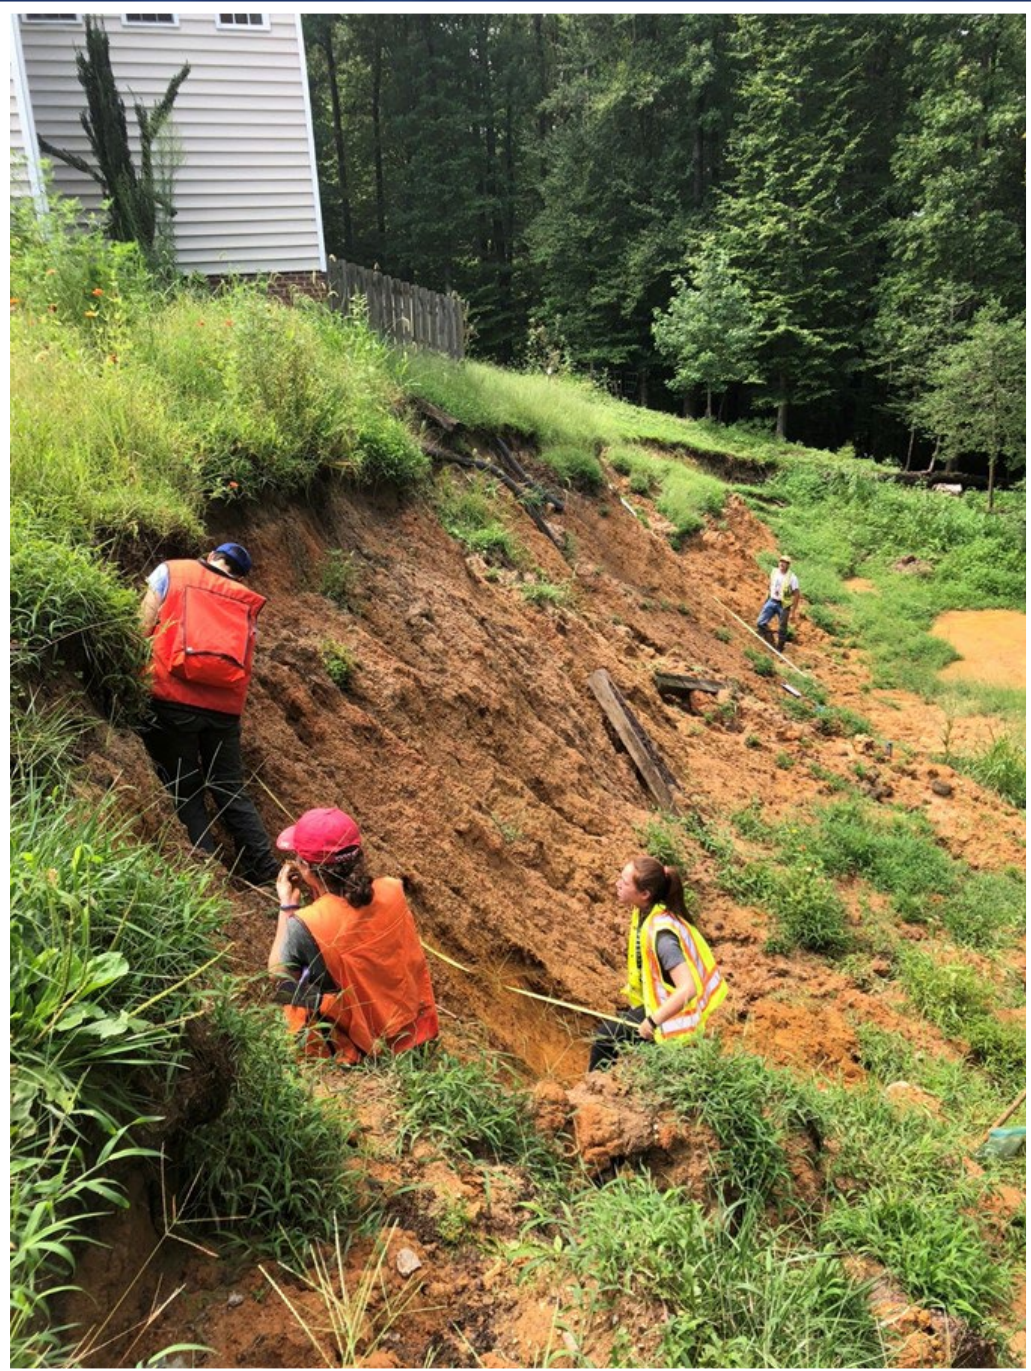
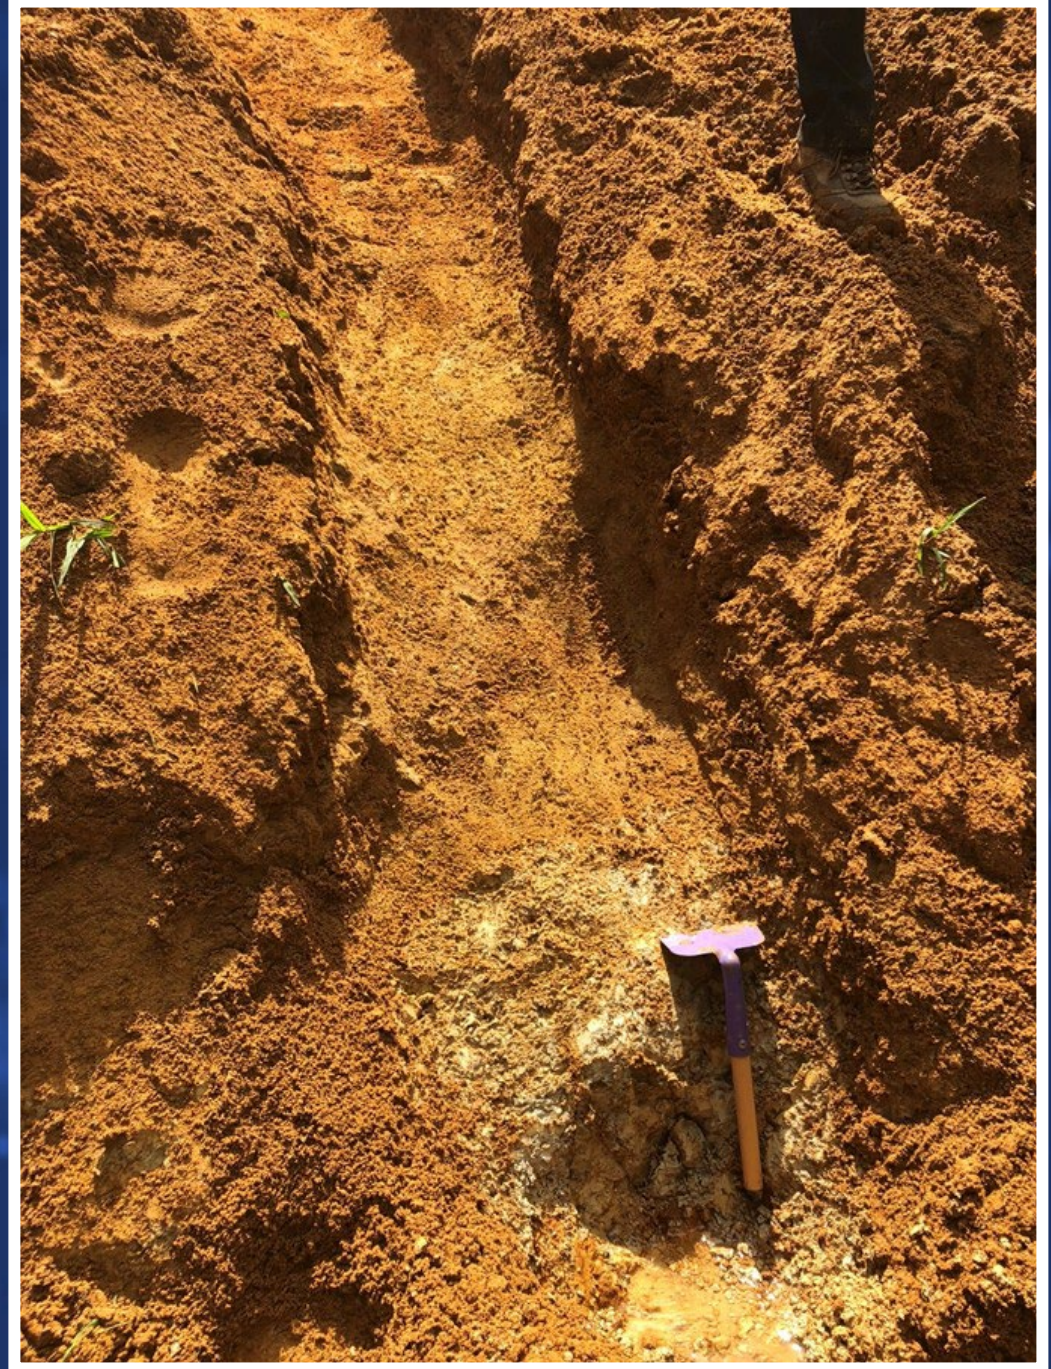
- Stratigraphy of the landslide headscarp examined by DGMR and USGS on August 1
 - Cold Harbor – 0-8.9 ft
 - Yorktown – 8.9-18 ft
 - Eastover – 18 to base of headscarp
- Eastover Formation – well-jointed, firm, silty clay that breaks easily along joint faces and fracture surfaces
 - When exposing with hand shovel, groundwater readily flowed from fractures in the clay

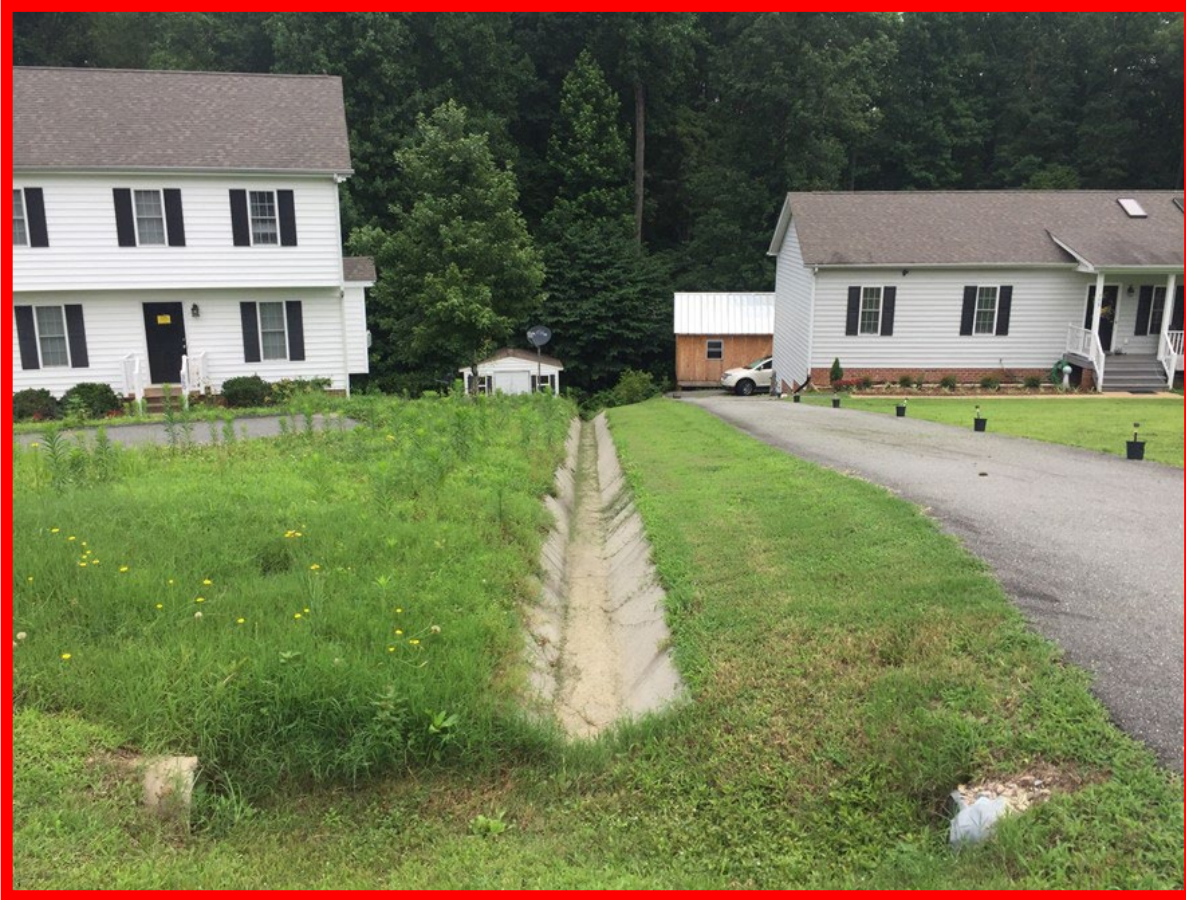
- Storm water runoff also contributed significantly to the slide and probably accelerated the reactivation of the slope
 - Concrete-lined storm drain between 358 and 360 Nottoway drains into the right-lateral flank of the landslide
 - Driveways between 360-362 Nottoway provided conduits for rainwater

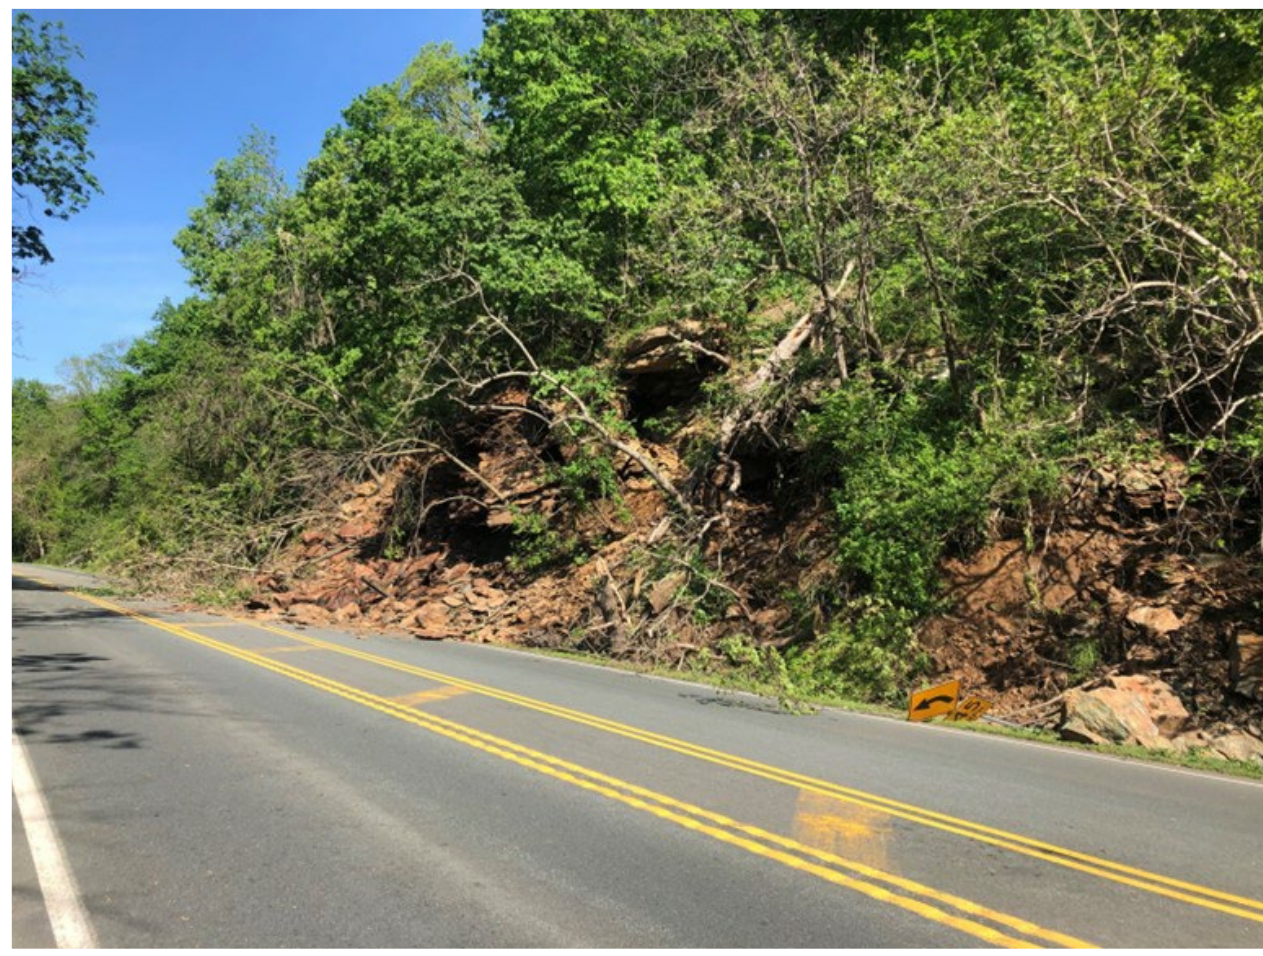
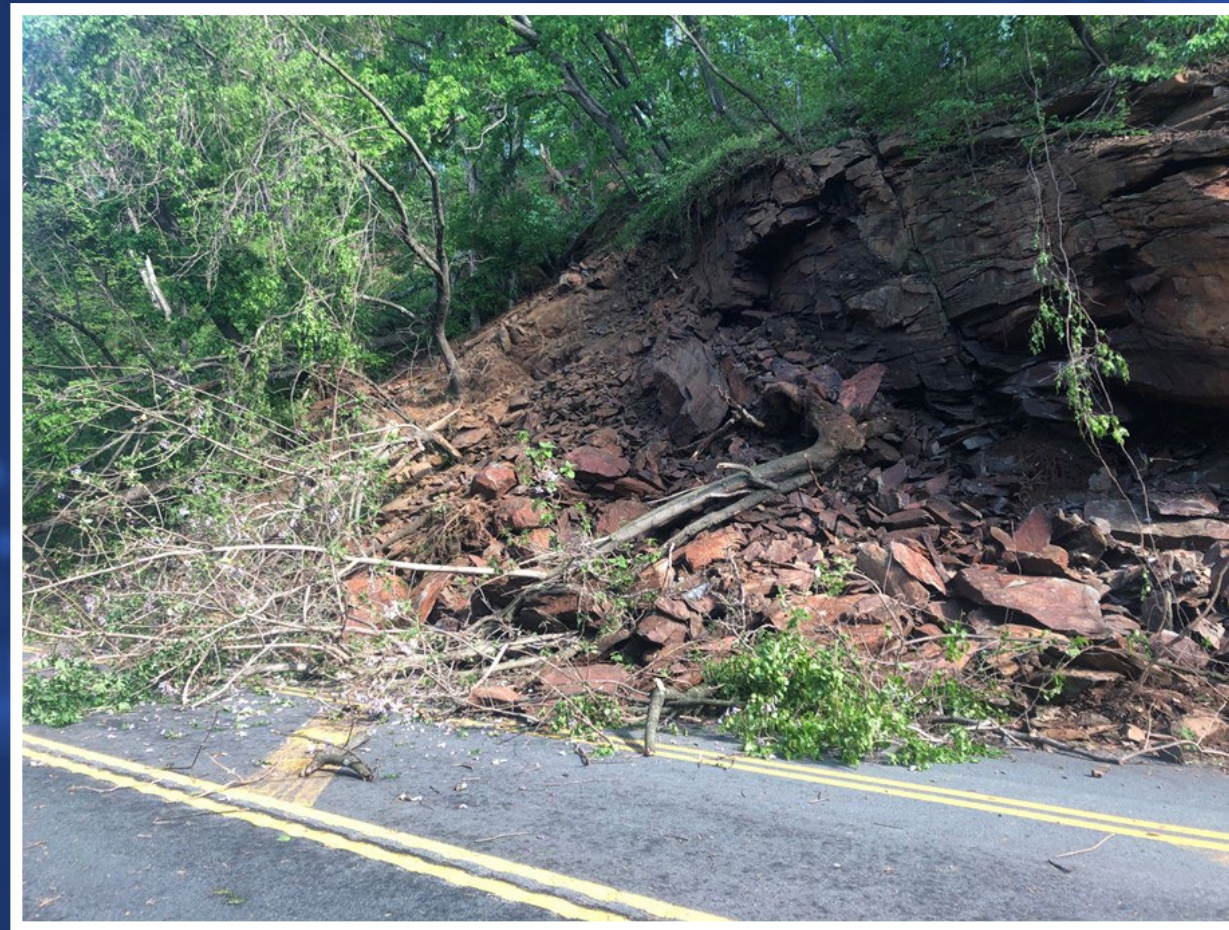
- Occurred on May 3, 2021 near Rockfish Gap
- US 250 closed between Route 6 and US 151 as rock and debris was blocking the westbound (uphill) lane
- Contacted VDOT and was allowed to do a site inspection the next day

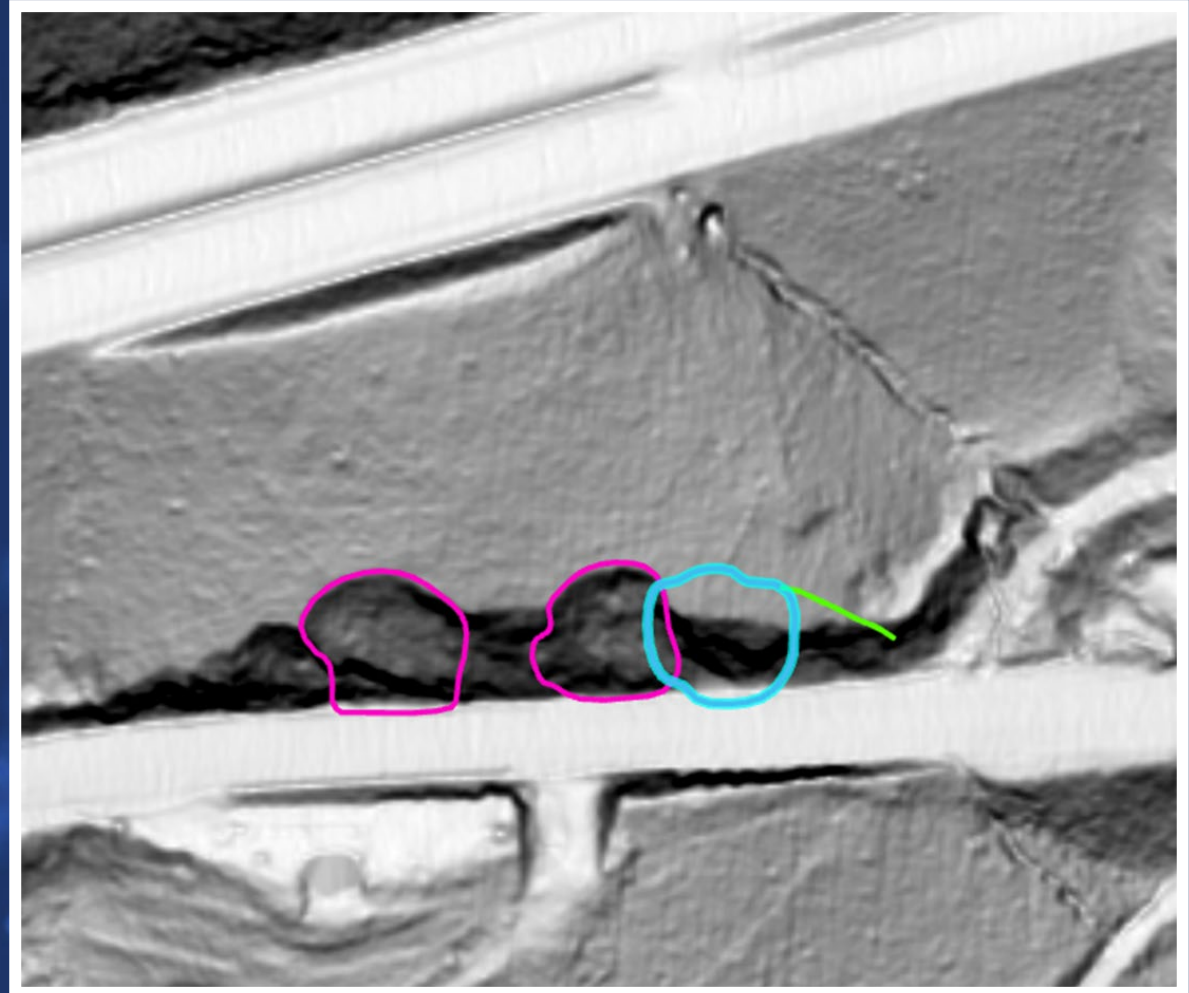
- This was classified as a rockslide on site, due the material and style of movement.
- A large tension crack to the east indicated that additional movement could occur.
- Also the site of other past rockslides which could be identified on aerial photography and LIDAR.

- Slide occurred in the Catoctin Formation – 570-million-year-old meta-basalt (greenstone)
- Later metamorphism deformed and sheared the rock creating foliation
- In this area of US-250 and I-64 the foliation dips downhill, parallel to the slope → became the failure surface of the rockslide

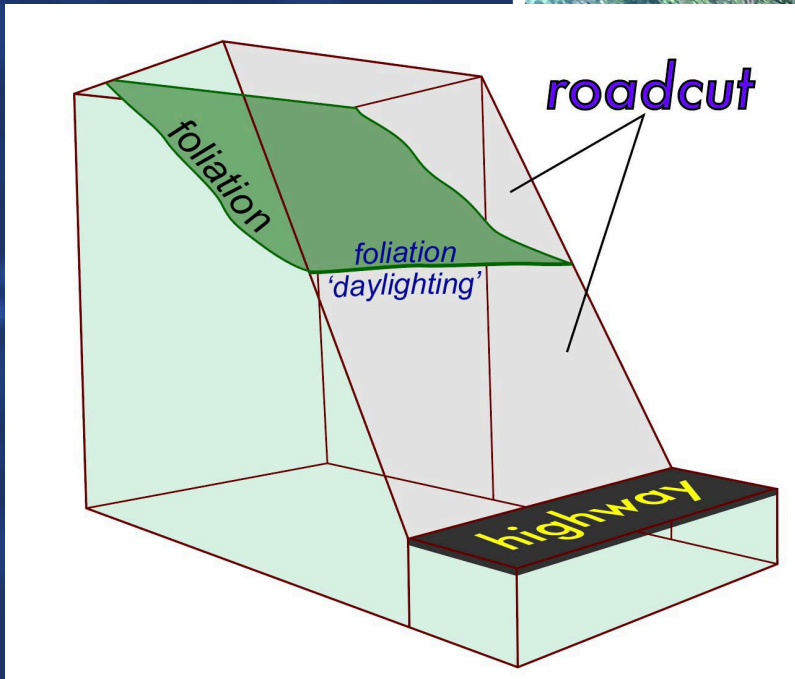
Road cut along
US 250 is steep
with daylighting
foliation
surfaces.

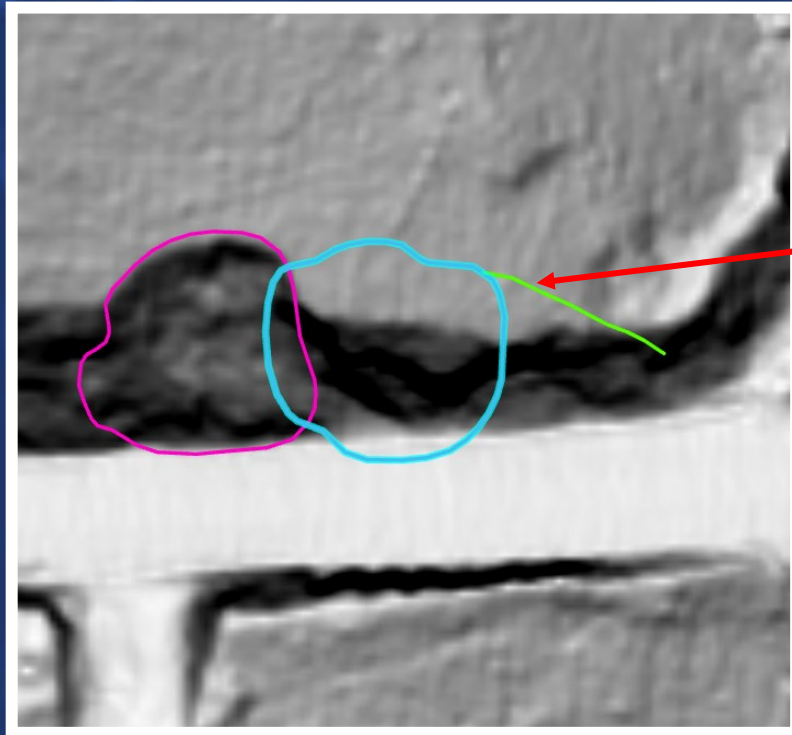
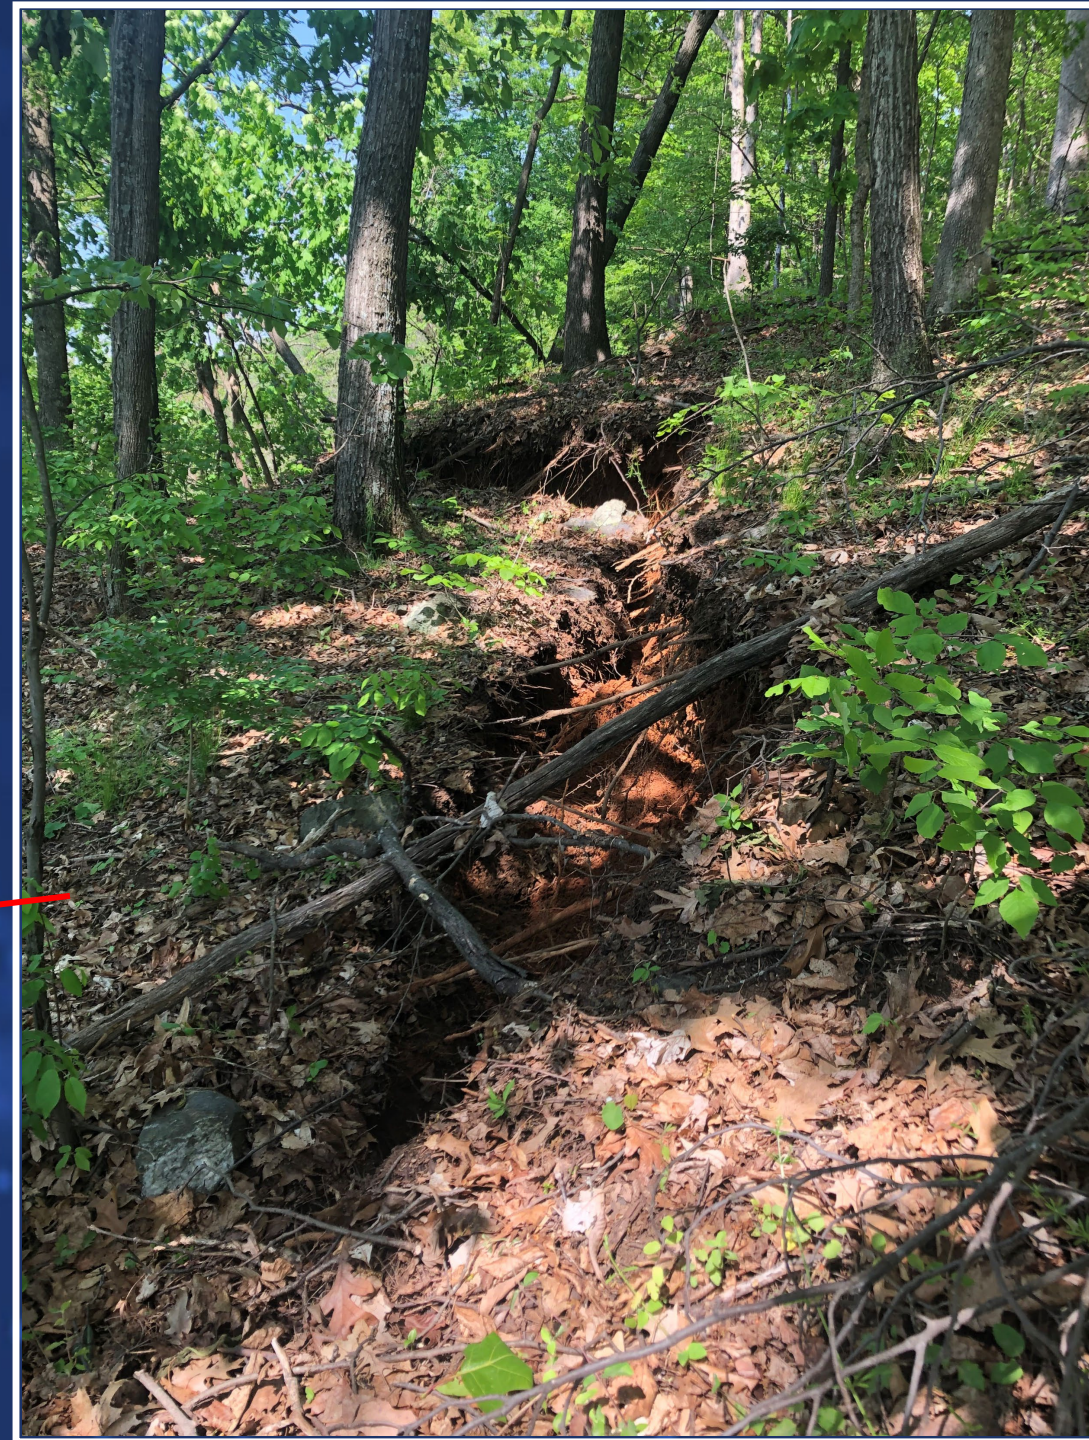
Tension cracks and scarping did not extend very far above the main headscarp, however the large tension crack to the east suggested that more of the area was unstable than previously thought.

- US 250 was closed for eight weeks and reopened June 30
- 700 dump trucks of unstable material were removed (about 10,000 tons) including the area below the large tension crack
- 350 soil nails were placed to stabilize the slope
- Area covered with anchored steel mesh to prevent soil and rock from falling into the roadway

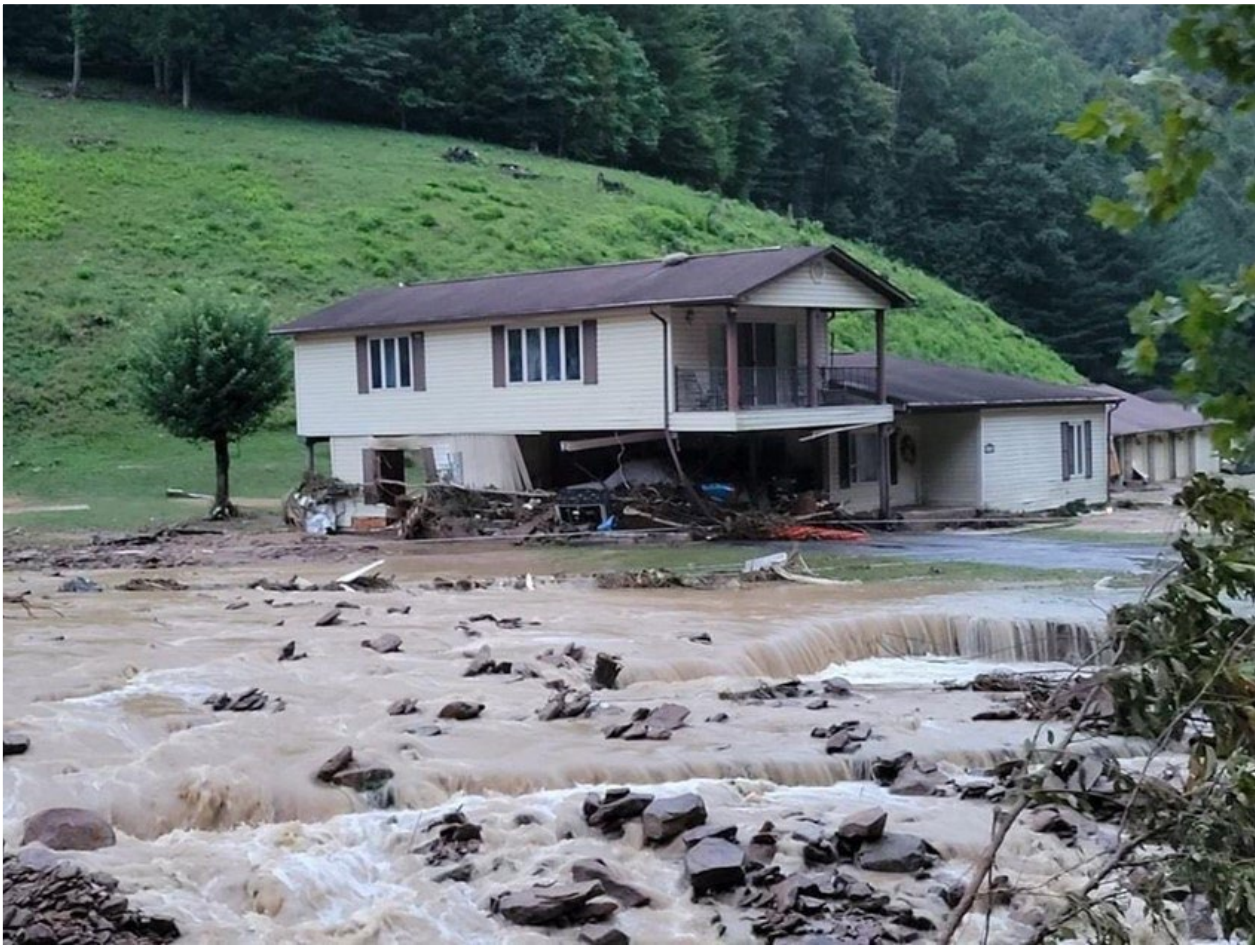
- Occurred on August 30, 2021 near the town of Hurley in SW VA
- “Coal country” – extensive surface and underground mining
- Severe flooding along Guesses Fork – seven-inches of rain in a few hours
- 31 structures destroyed, and 30+ damaged
- One person killed

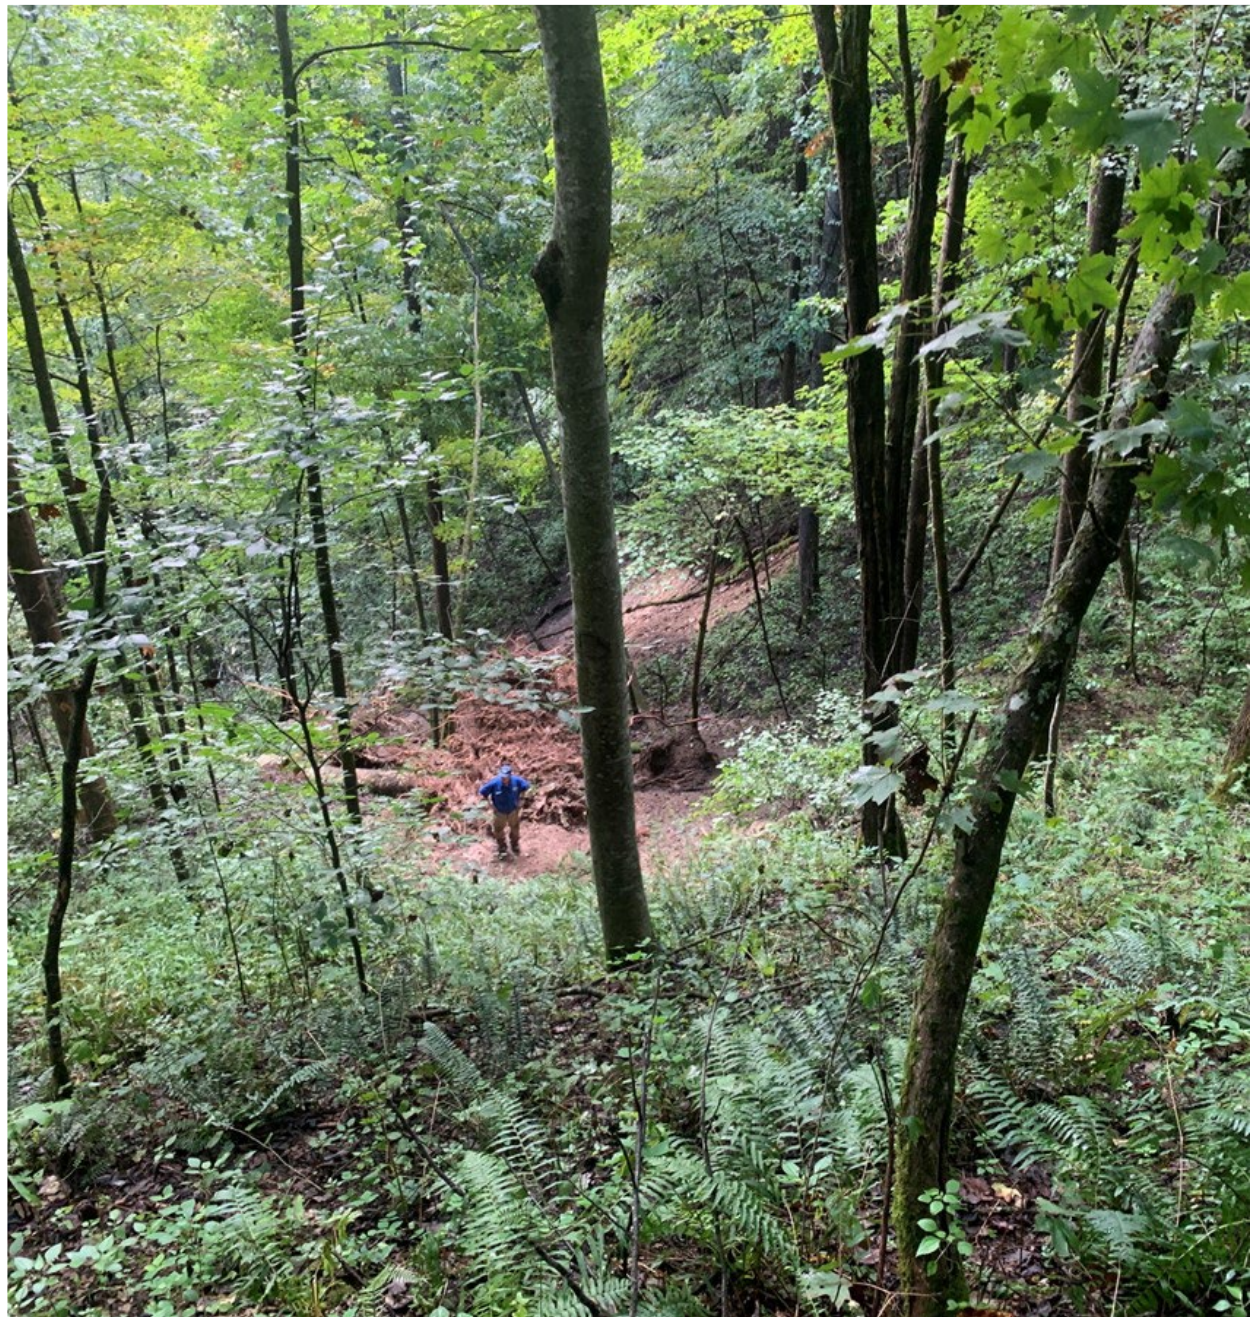
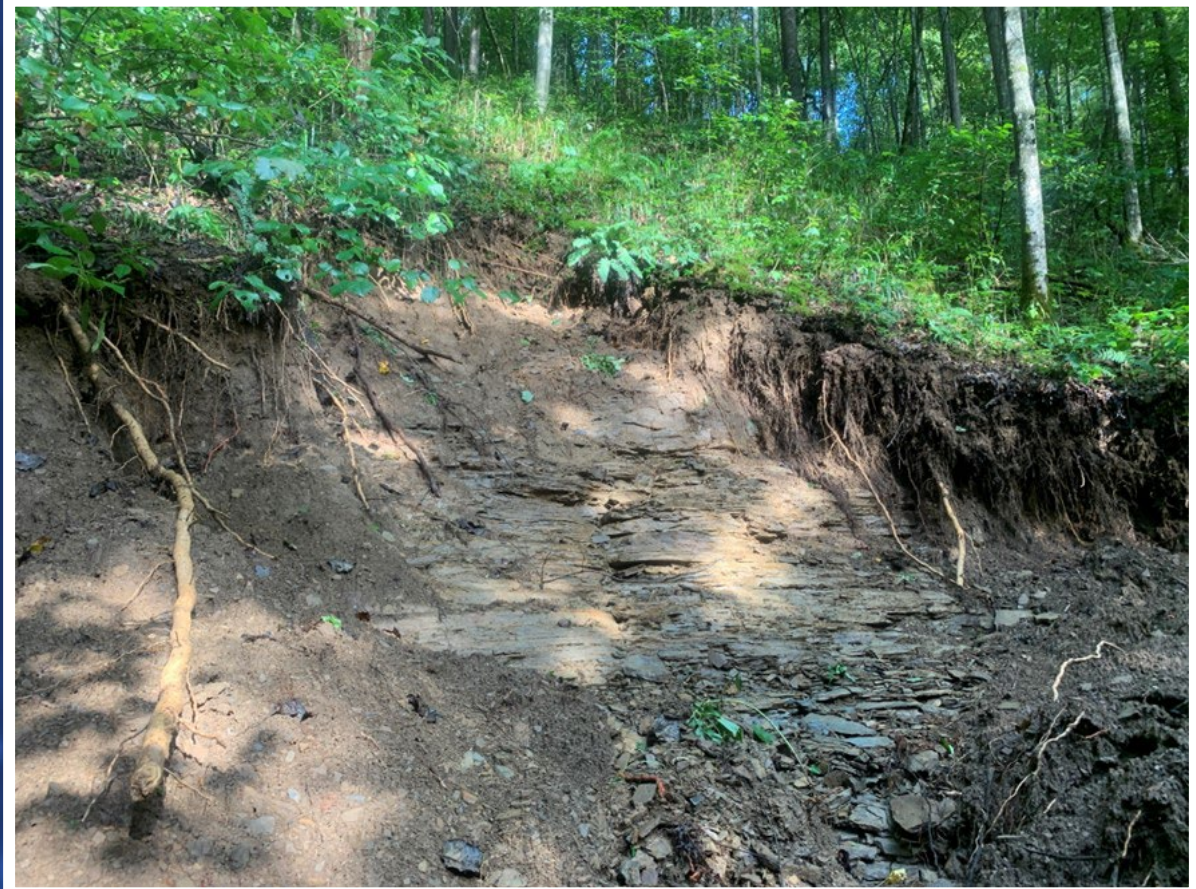
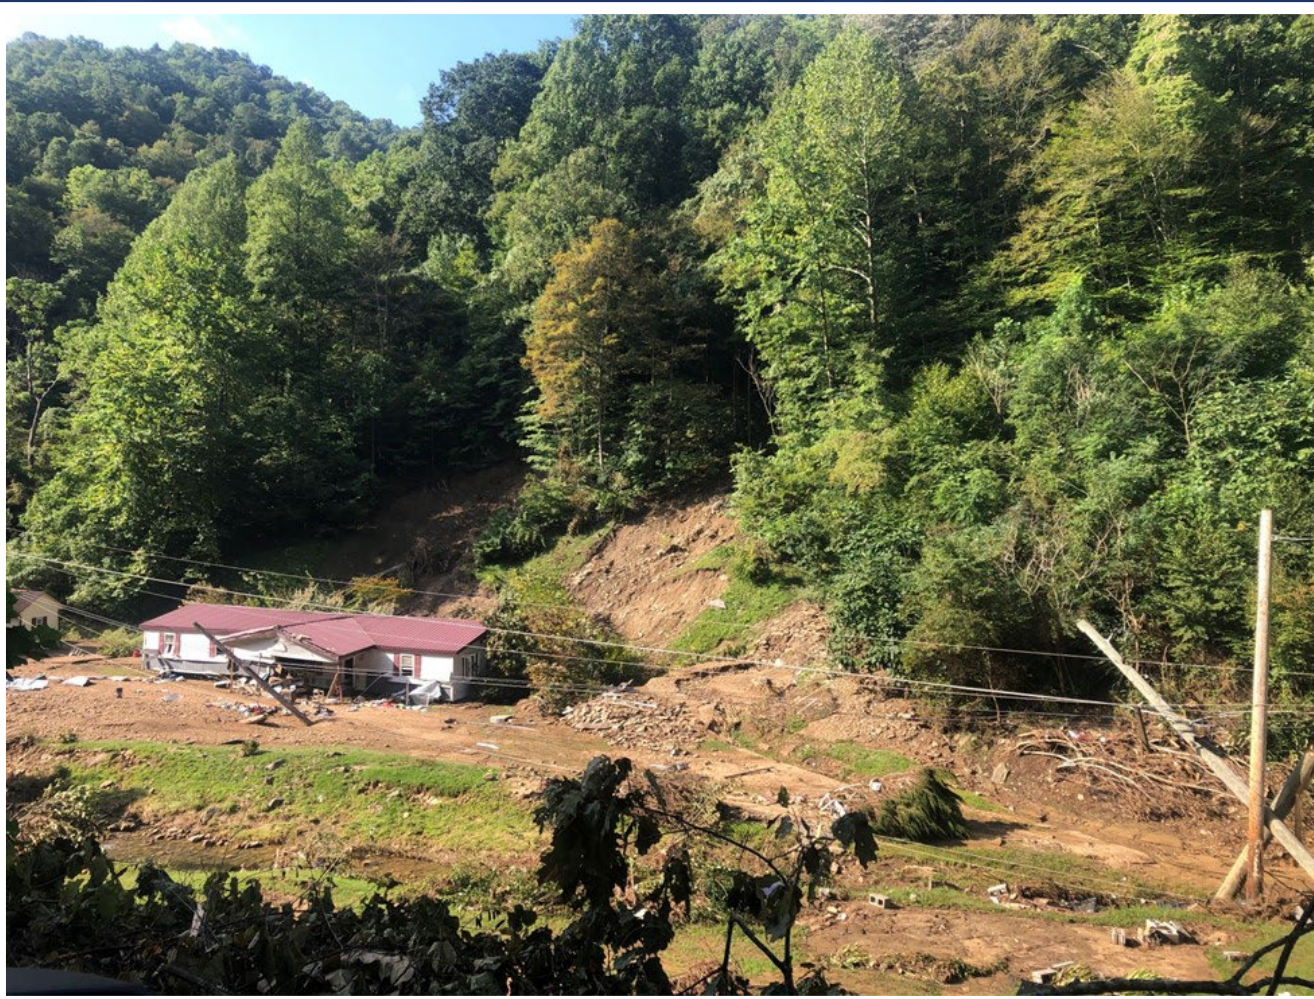
- VDEM requested emergency assistance related to landslides
- Field work and site assessment occurred Sept 8-9 after rescue operations were completed
- Concern that flooding was related to mine portal blowouts
