INVESTIGATING LANDSLIDES IN VIRGINIA *IDENTIFICATION, MAPPING AND EMERGENCY RESPONSE*

ANNE CARTER WITT - GEOLOGY AND MINERAL RESOURCES PROGRAM
ANNE.WITT@ENERGY.VIRGINIA.GOV

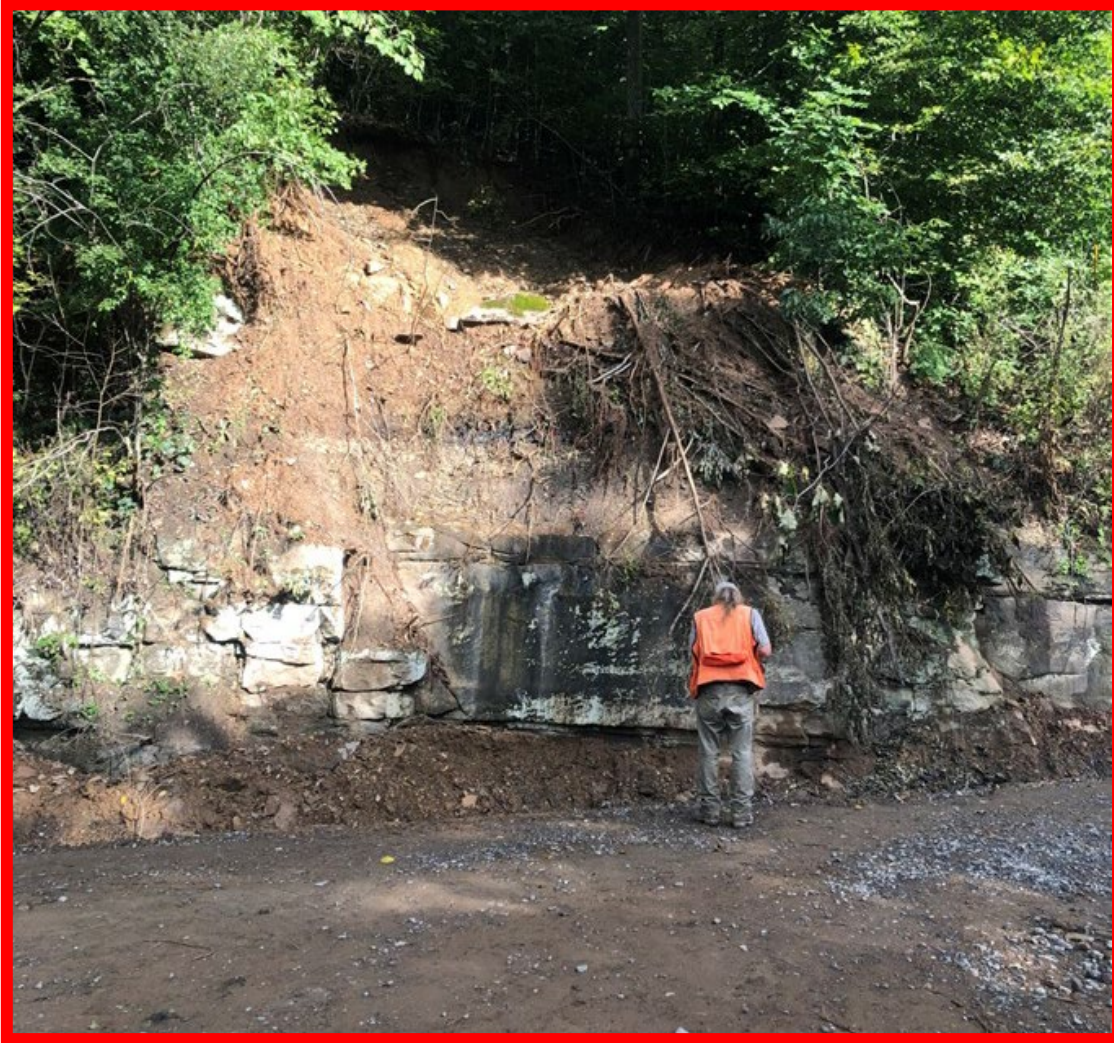
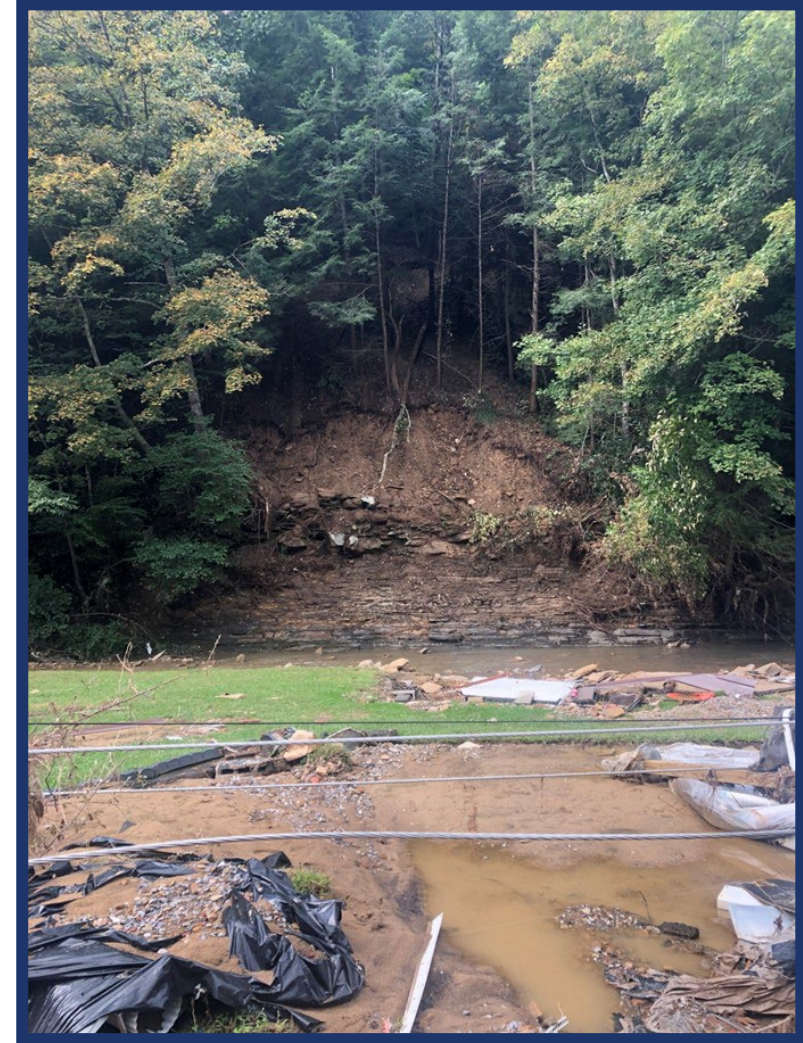
DEBRIS SLIDES

- Mapped 47 landslides
 - Most were debris slides
 - 21 were road related
- Concentrated within a 20 mile area
- Likely more landslides than documented
 - were not visible due to vegetation
 - inaccessible due to storm damage
- Did not see evidence of mine portal blowouts, but a few slides originated from mine benches
